Viking CCS pipeline

# Preliminary Environmental Information Report Volume IV

Appendix 11.2

# Site Visit Technical Note

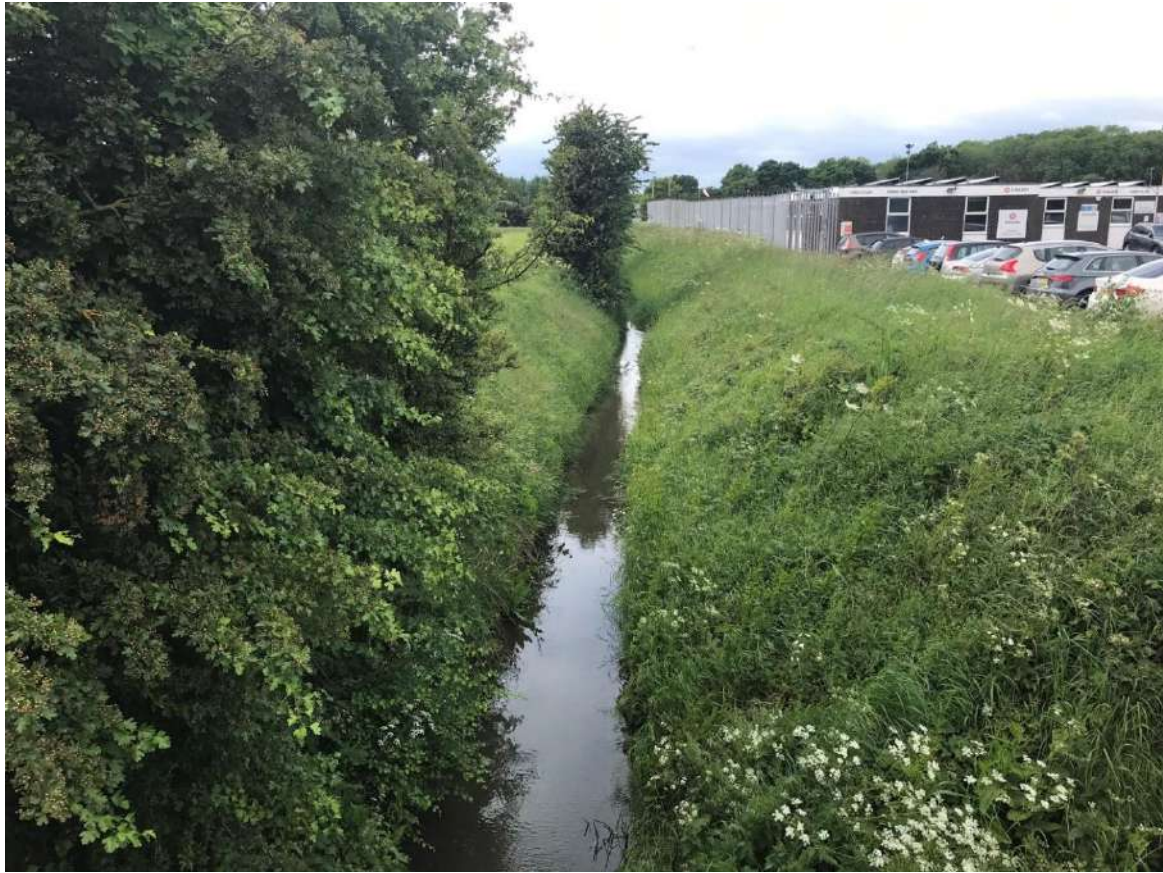
11.3.4 The watercourse was surveyed at the existing Manby Road crossing to the north of Immingham. The watercourse flowed through an area of flat land and was bordered by agricultural fields and industrial units. The watercourse has been significantly modified for drainage, having been straightened, deepened and widened. As a result, the watercourse displays no morphological diversity, and the straight trapezoidal channel provides little opportunity to provide quality habitat. The steep banks were

approximately 2 m high and vegetated with grasses, with some scattered trees present. The bed was primarily comprised of silt.

**Photograph 11-1: Harborough Marsh Drain (Site 1a) View Upstream**

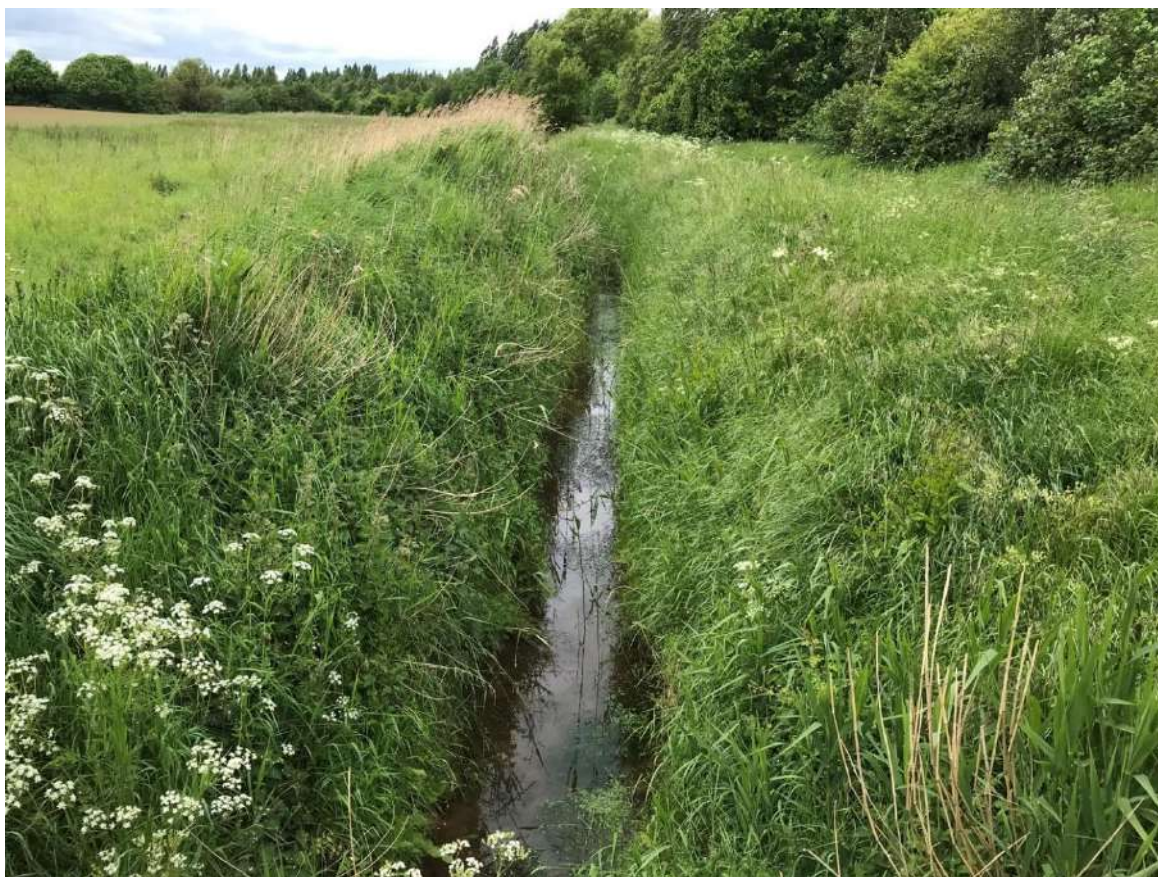
11.3.5 At Site 1c Harborough Marsh Drain displays a similar straight planform and trapezoidal cross section as it does at Site 1a. The banks were a similar height to Site 1a, and largely comprised grasses, although there was a length of the right bank that was vegetated with dense tree cover. As with Site 1a, the drain displayed no morphological diversity. The bed was comprised of silt and had considerable macrophyte growth. Adjacent land use is predominantly agricultural, with a former golf course on land on the right.

***Photograph 11-3: Harborough Marsh Drain (Site 1c) View Upstream***

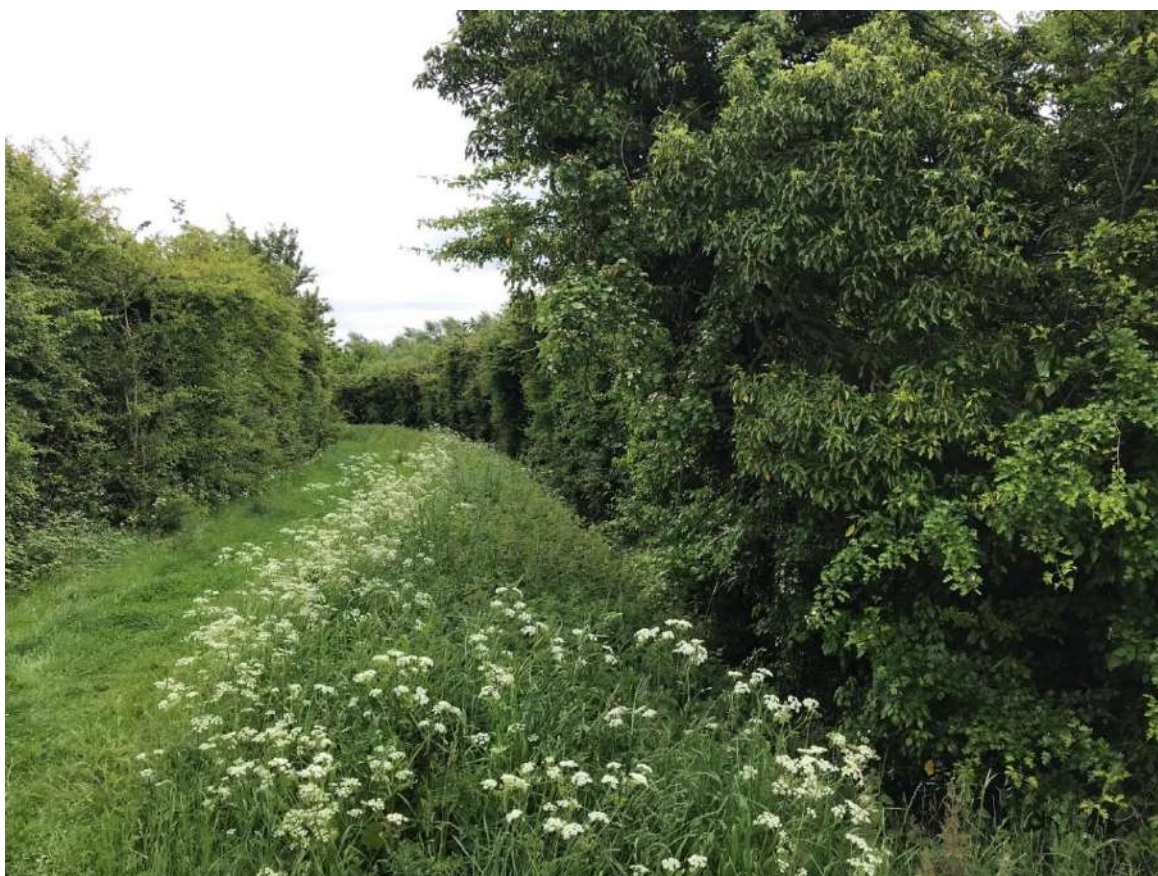
***Photograph 11-4: Harborough Marsh Drain (Site 1c) View Downstream***

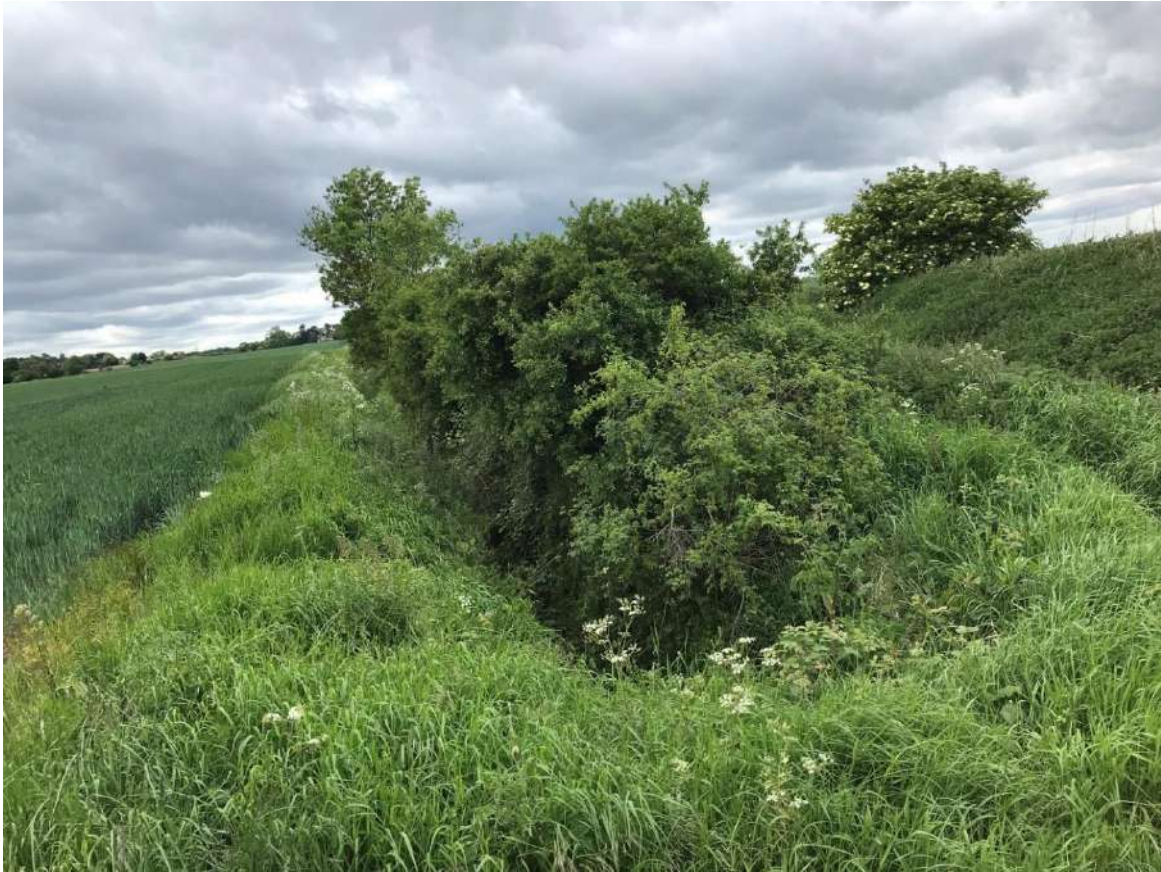
11.3.6 Site 1d is located on a drain connected to that on which the previously detailed sites lie. The drain at this location displayed a highly modified planform and cross section, having been straightened, deepened and widened for agricultural drainage. The banks were approximately 2 m high and vegetated with grasses and trees. Surrounding land use is predominantly agricultural fields.

***Photograph 11-5: Harborough Marsh Drain Tributary (Site 1d) View Upstream***

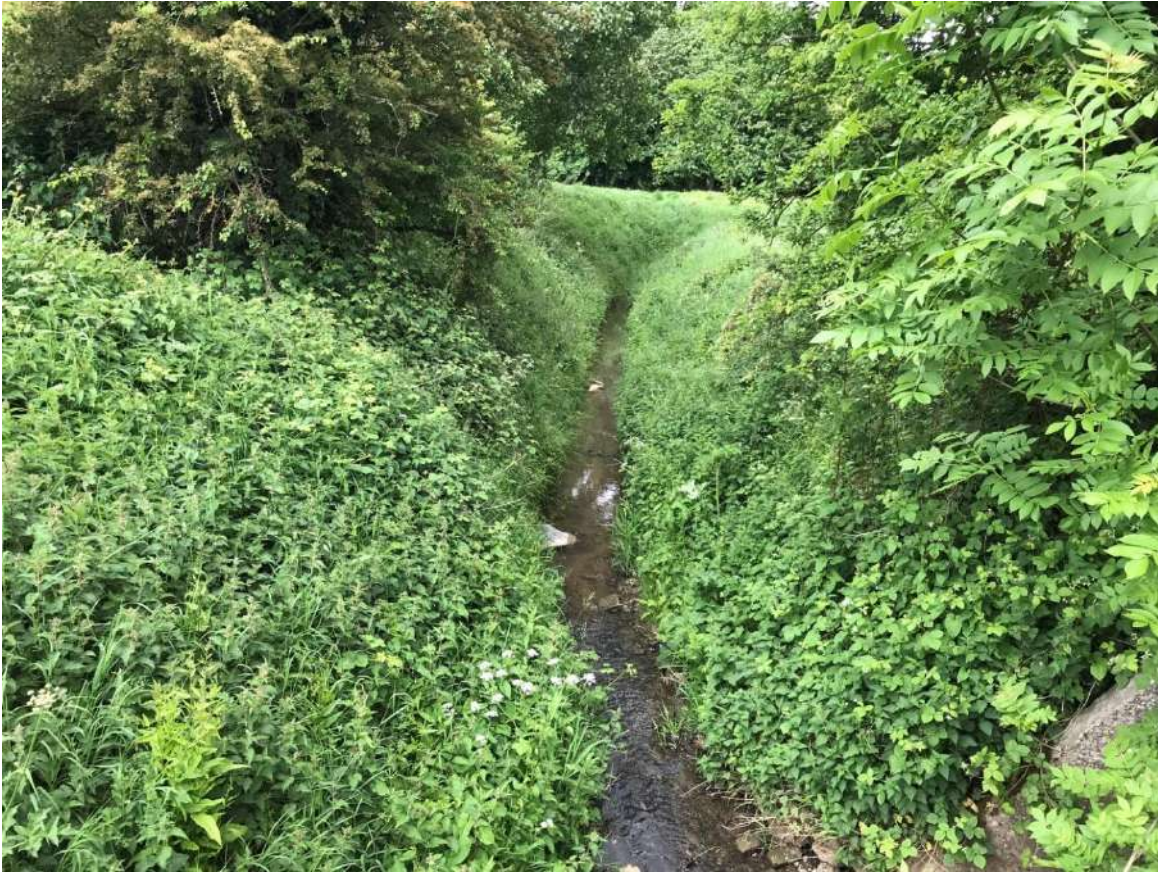
11.3.7 The watercourse at Site 1f was again a different watercourse connected to the drains detailed previously. The site is located at the existing Mill Lane crossing. The watercourse was heavily modified as was seen at the previous sites, with a similar cross section. Some coarser material on the bed did, however, provide some minor flow variation, although the channel was largely devoid of morphological features.

*Photograph 11-6: Harborough Marsh Drain tributary (Site 1f) View Downstream*

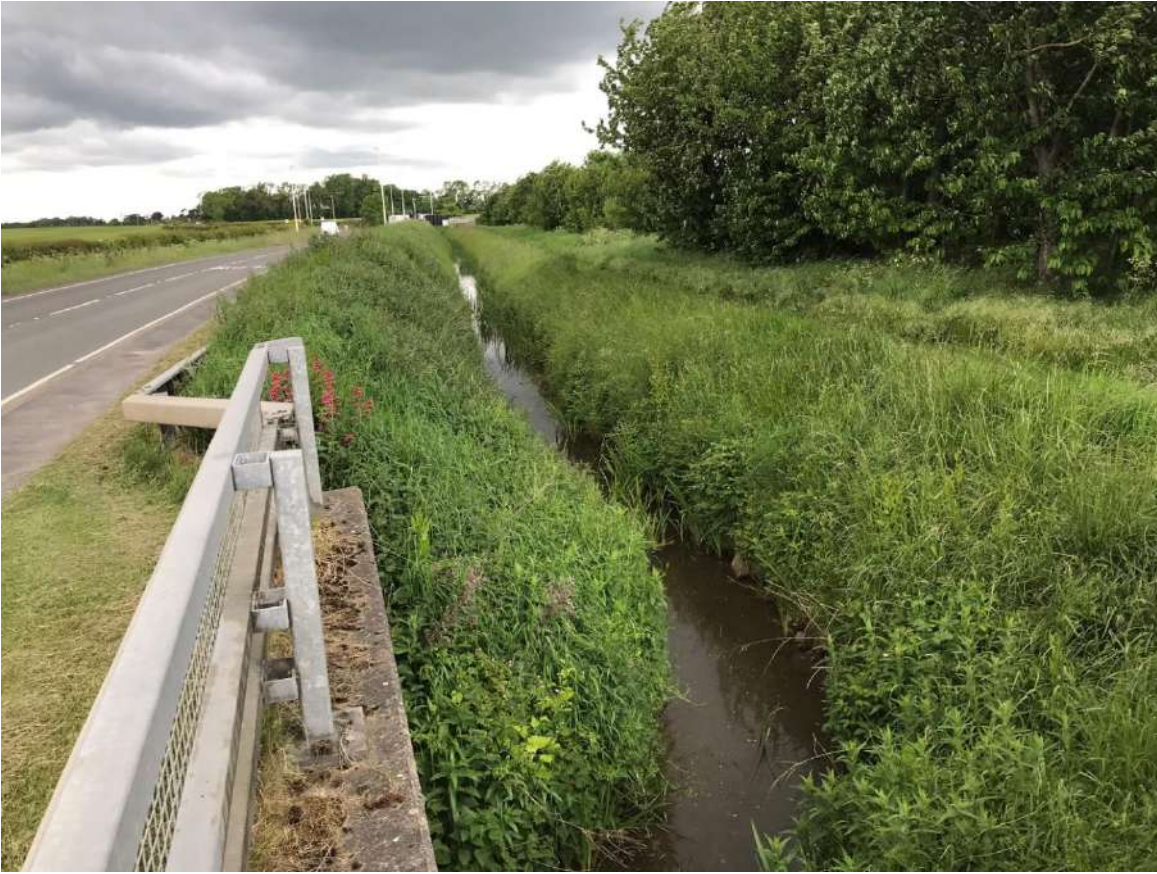
11.3.8 Site 1g is located where the watercourse is crossed by Harborough Road. The watercourse has been straightened along the road and upstream of the crossing. There was no perceptible flow at the time of survey and the water was very turbid, indicating the presence of fine sediment which likely enters the watercourse from the road and surrounding agricultural land via runoff. The banks were heavily vegetated with grasses and herbs and were both quite steep. The left bank was higher at the downstream end, at around 2 m, due to it bordering the road which is raised above the surrounding land. The left bank was approximately 1.5 m high. Emergent, linear leaved macrophytes were present on the bed, indicating the presence of finer bed substrate.

*Photograph 11-8: Harborough Marsh Drain (Site 1g) View Downstream*

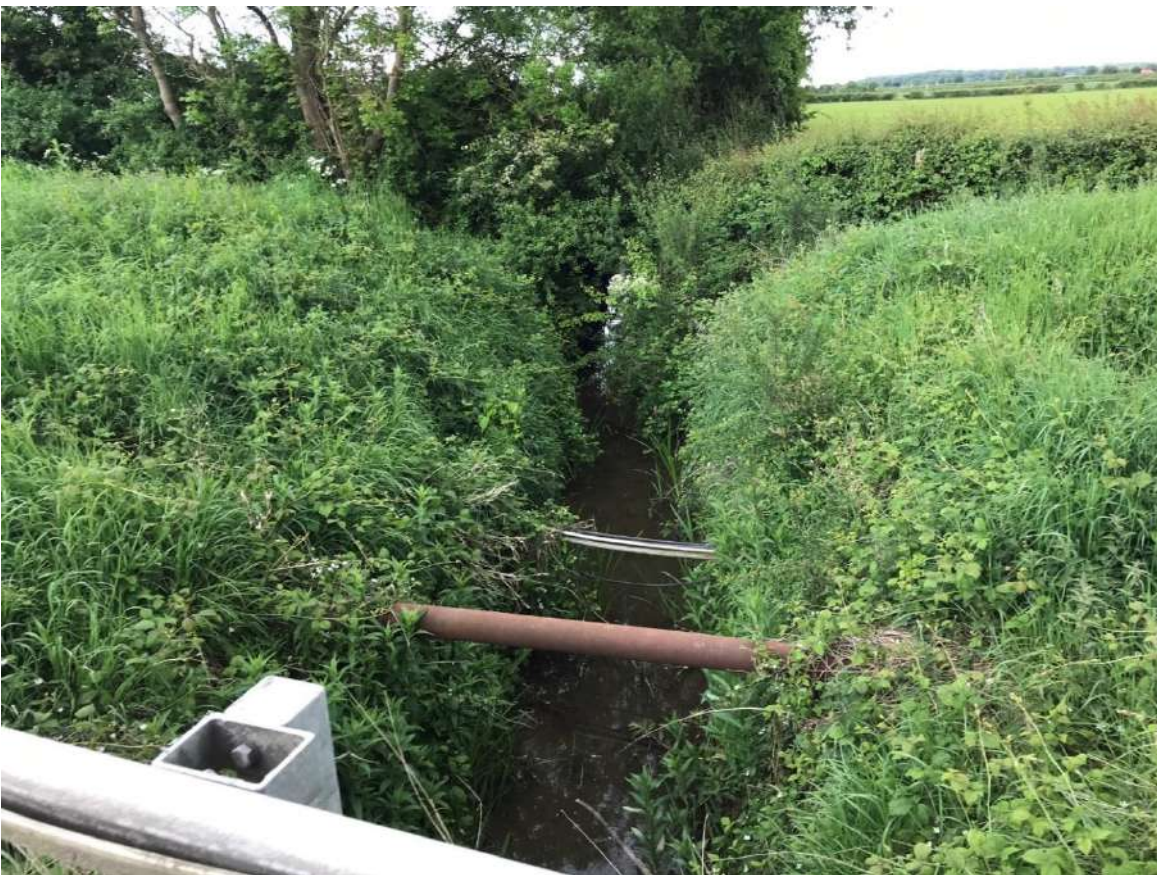
*Photograph 11-9: Harborough Marsh Drain Tributary (Site 1g) View Upstream*

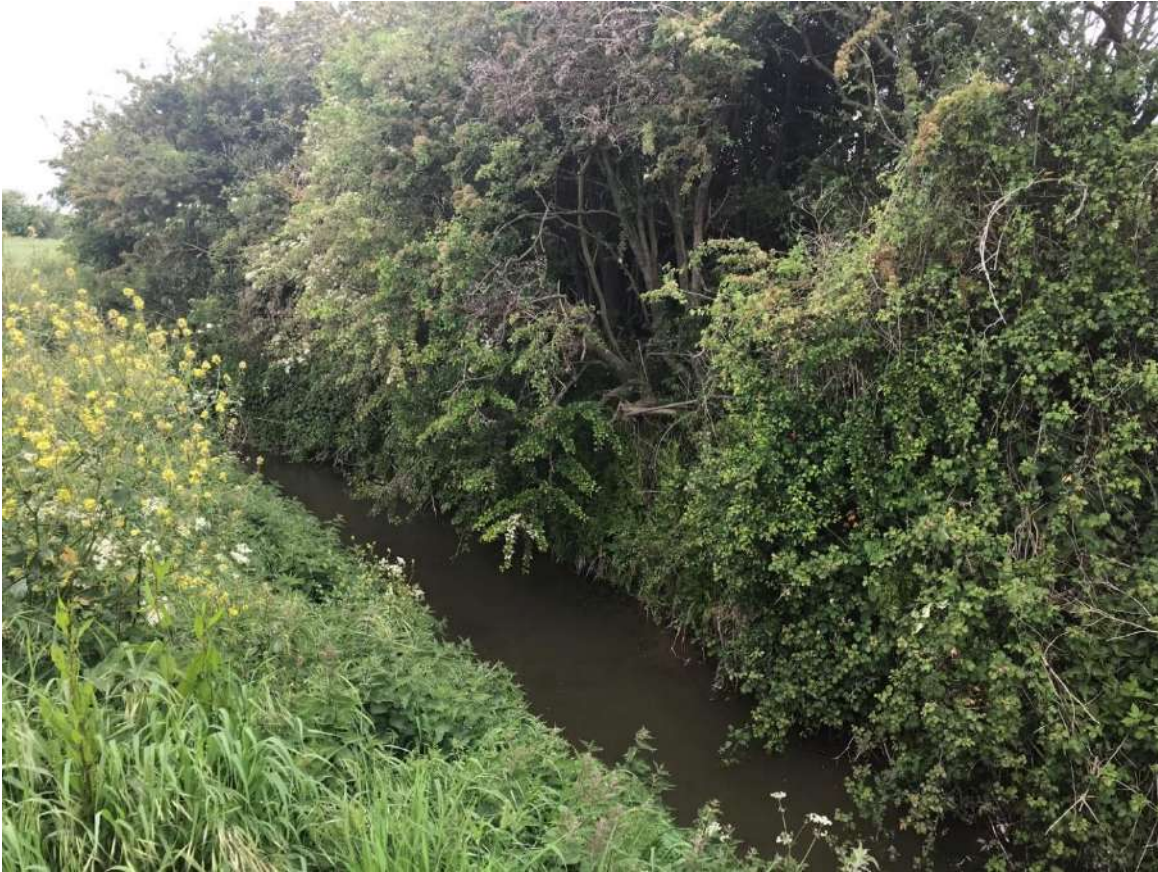
- 11.4.1 Site 2 is located on a straightened length of North Beck Drain, within an area of flat agricultural land. The watercourse planform has remained largely unchanged since 1908 according to historic OS mapping, although some straightening has occurred a short distance upstream of Site 2. The straightening of the length at Site 2 evidently occurred prior to 1908.

- 11.4.2 The channel was incised, disconnecting it from the surrounding land, with banks of approximately 2 m height. The channel was devoid of morphological diversity through this straightened length, and was characterised by laminar gliding flow. Bed substrate was predominantly silt and turbidity was quite high. A short distance upstream of Site 2 the watercourse displays a more natural sinuous planform. Morphological and flow diversity are much greater through this sinuous length, with embryonic riffles and bars present along with a variety of flow types. Both banks were predominantly vegetated with long grasses and herbs, with some scrub present in parts. The riparian zone on the left was wooded with a narrow strip of dense tree cover.

***Photograph 11-10: North Beck Drain (Site 2) View Upstream***

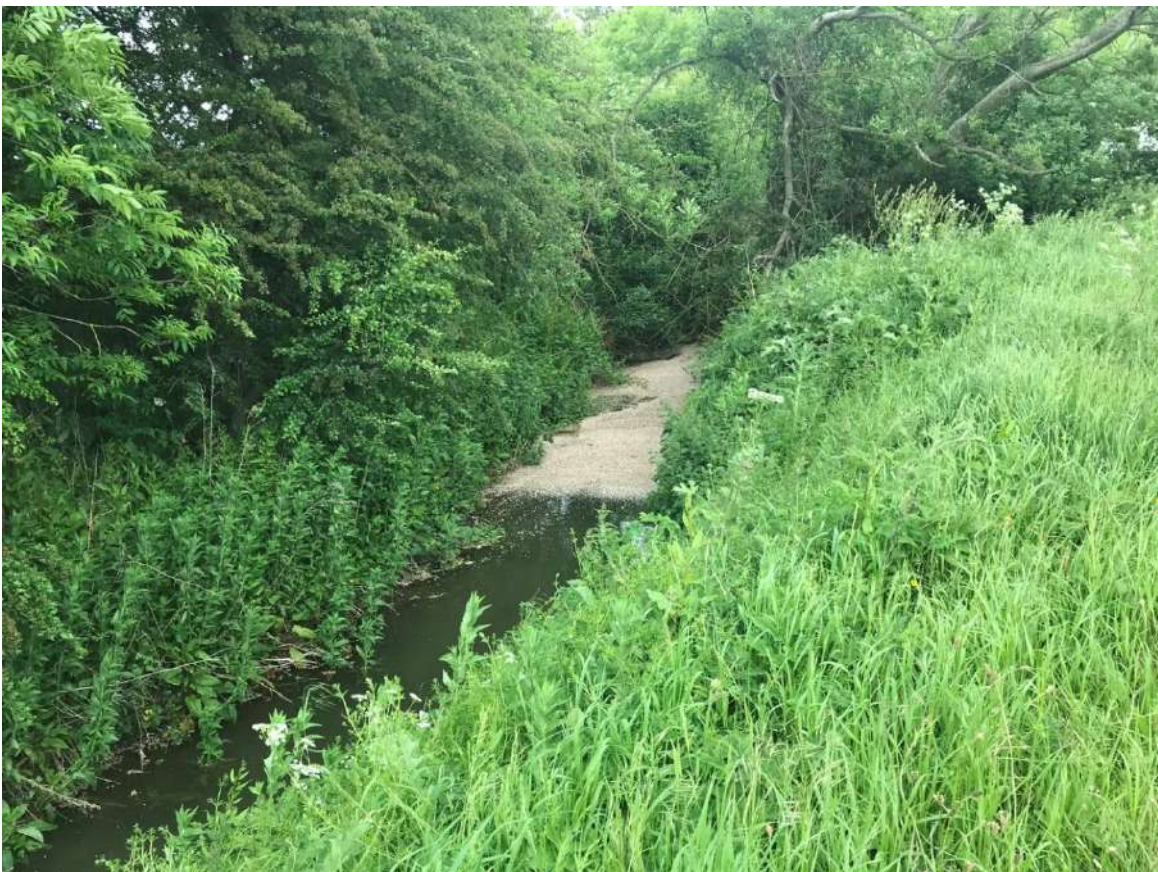
***Photograph 11-11: North Beck Drain (Site 2) View Upstream***

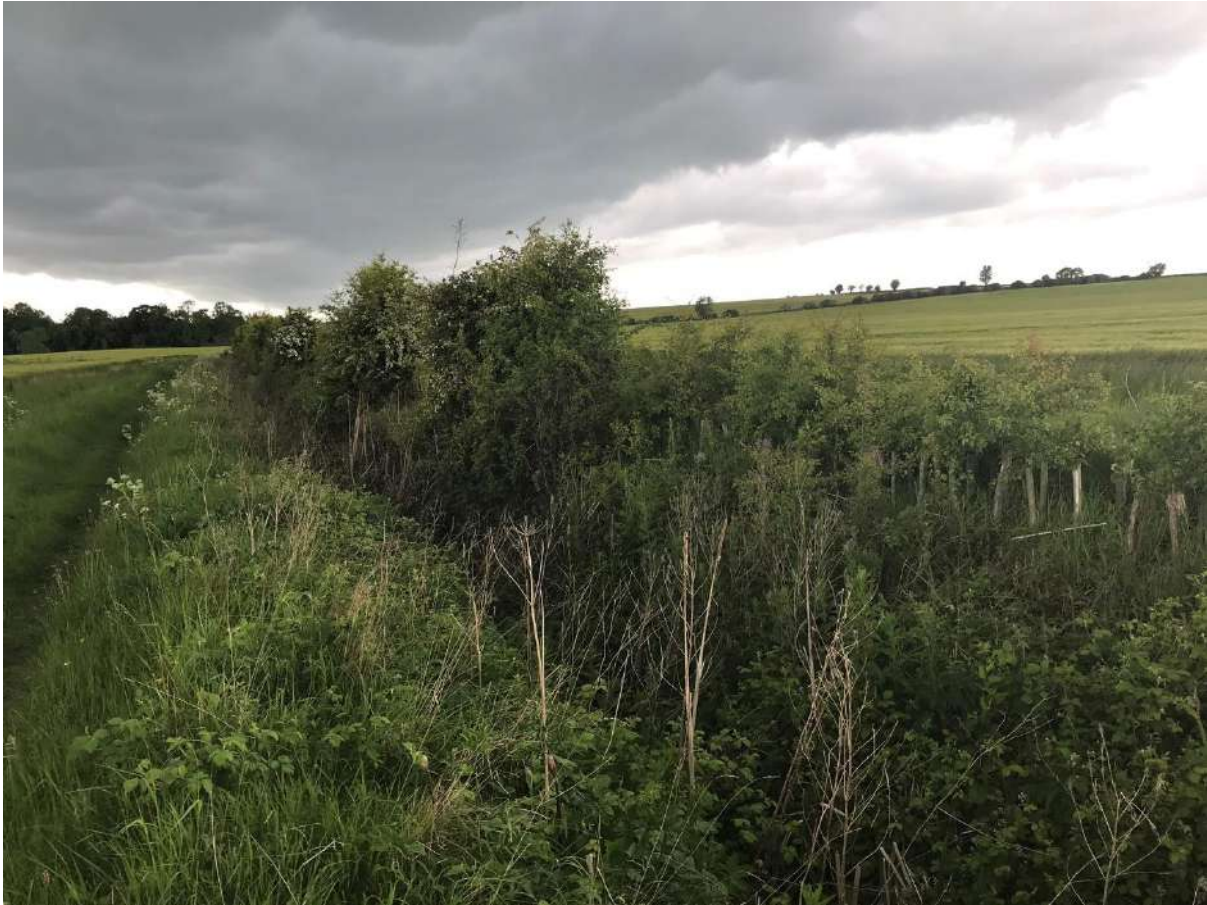
- 11.5.5 This linear drain is an artificial feature used for agricultural land drainage. The drain was heavily vegetated on the bed and banks during the survey which made observation of the bed difficult. There was no indication of water being present at the time of survey. A thin strip of trees was present in the riparian zone on the left bank.

***Photograph 11-13: Drain to Laceby Beck (Site 3a) View Downstream***

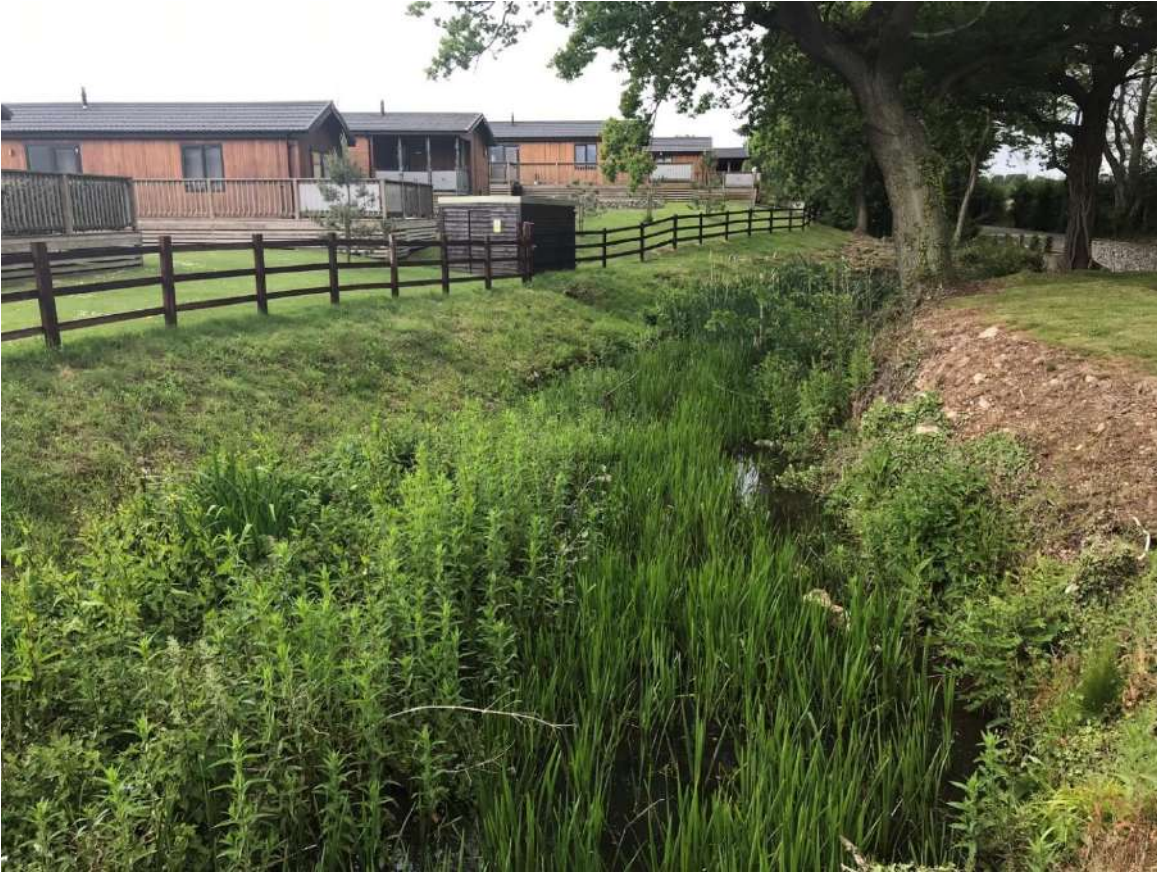
11.5.6 This length of Lacey Beck surveyed was located within the landscaped grounds of a holiday park and golf club, with the car park adjacent to the watercourse. The bank profile appeared to have been modified and natural bank vegetation had been cleared. The bed was heavily vegetated with reeds through the length that flows adjacent to the holiday park, and there was no perceptible flow. A large gravel bar was located on the right side of the channel downstream of the holiday park.

***Photograph 11-14: Laceby Beck (Site 3c) View Downstream***

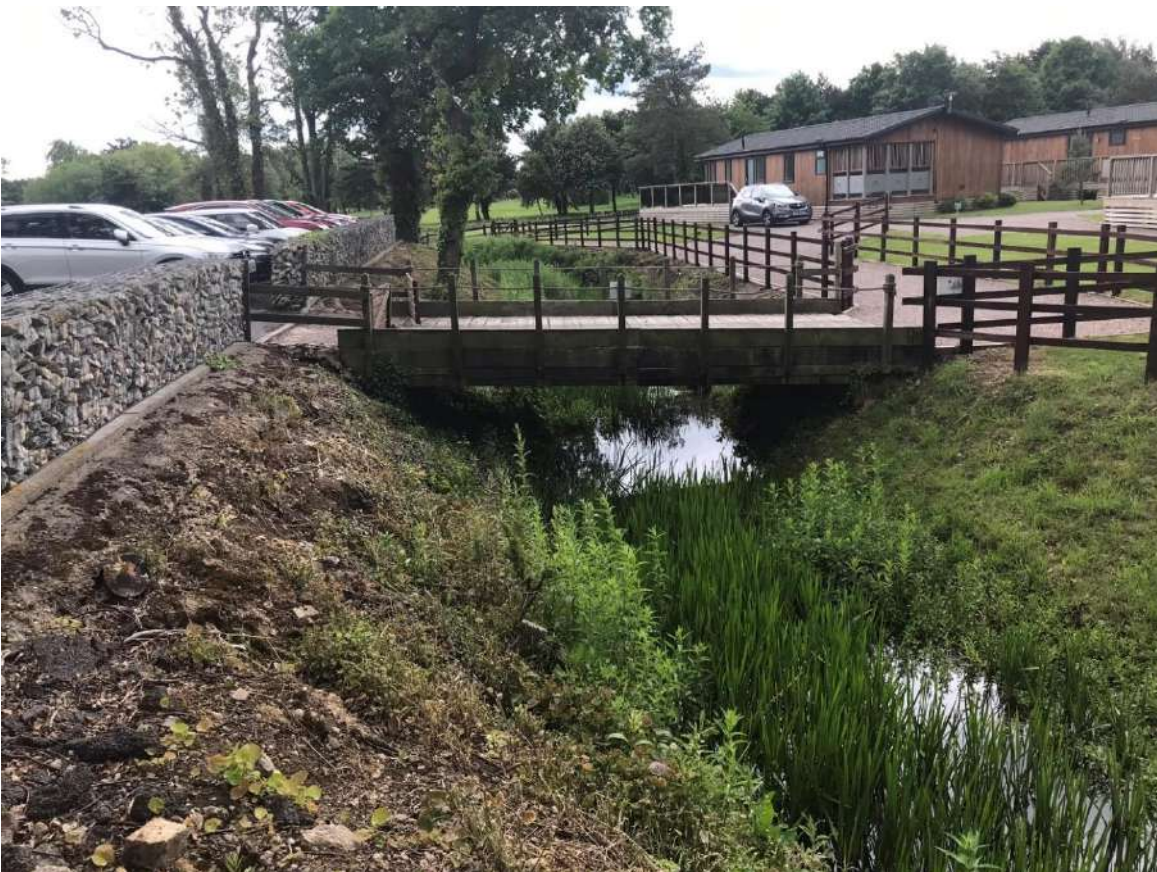
***Photograph 11-15: Laceby Beck (Site 3c) View Upstream***

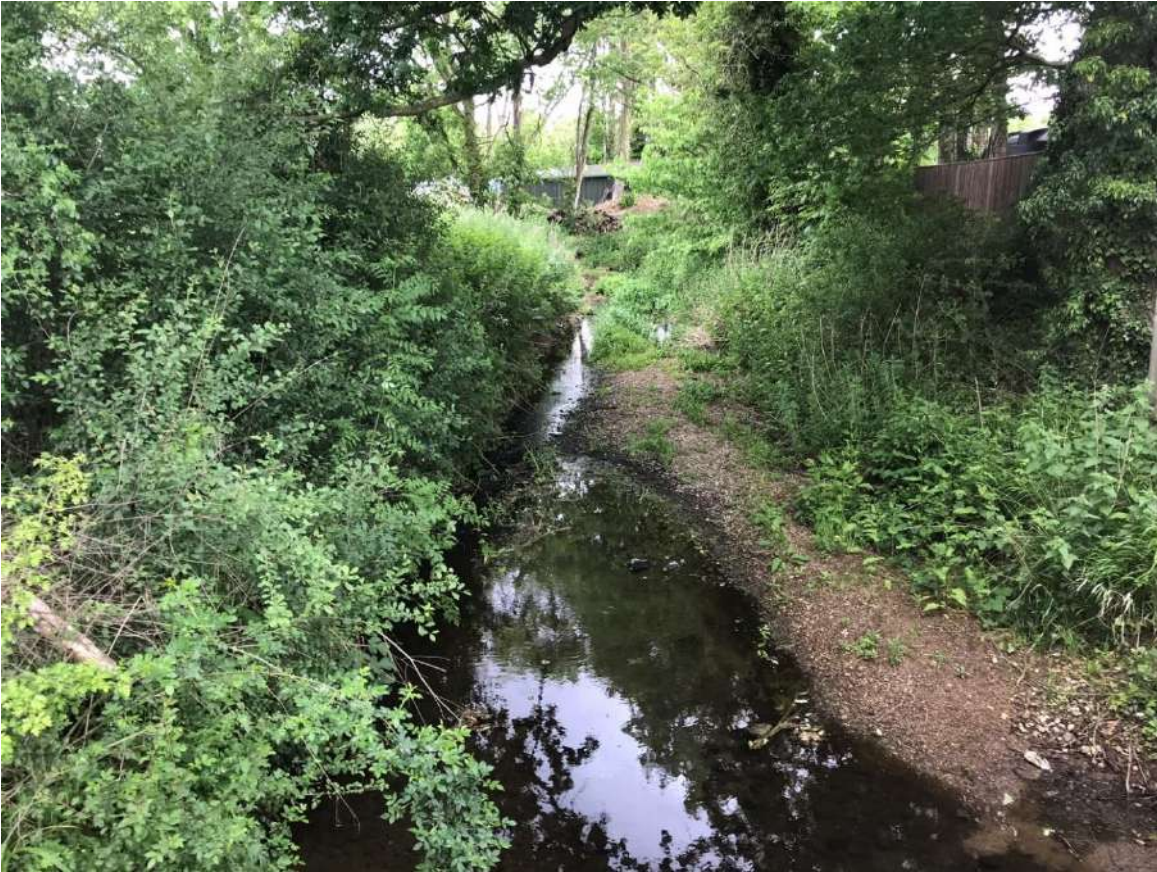
*Photograph 11-16: Laceby Beck (Site 3c) View Downstream*

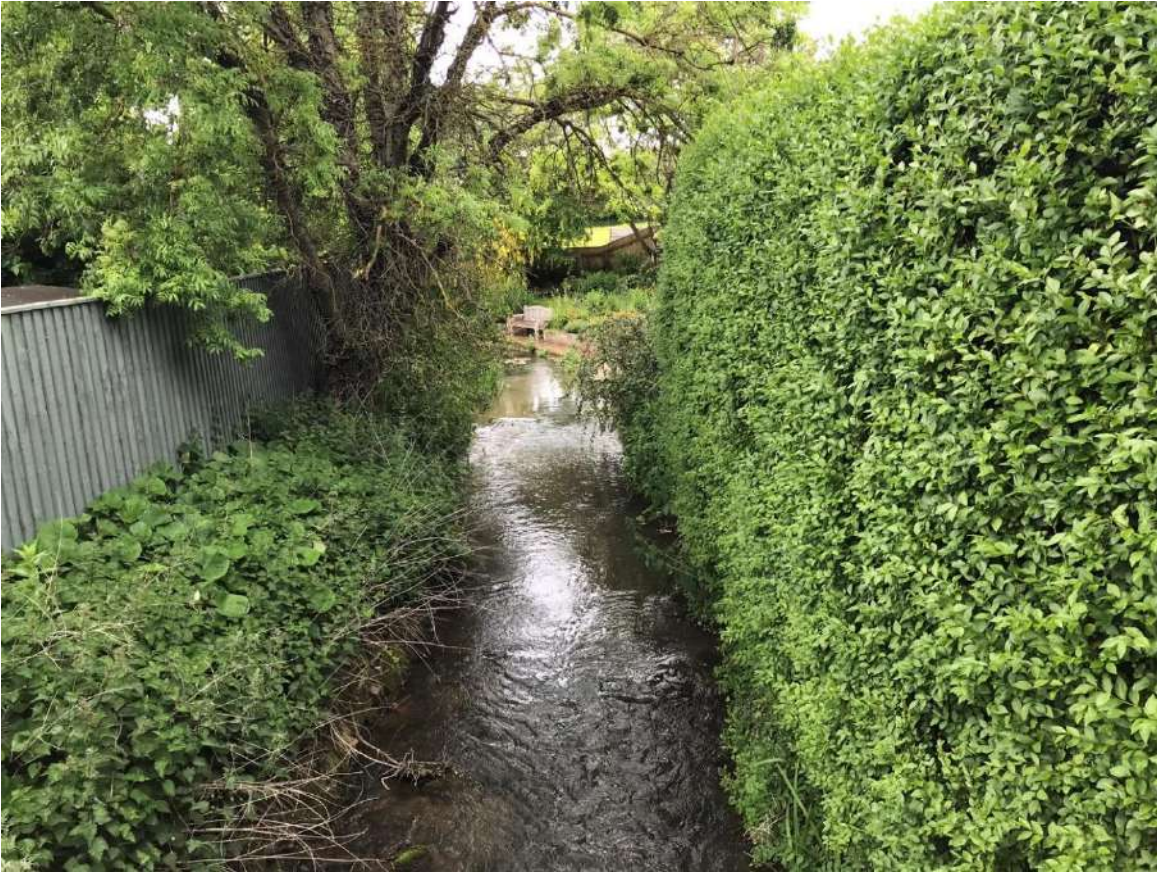
- 11.6.1 Waithe Beck has been straightened through the length on which Site 4b is located. Historic OS mapping dating from 1907 indicates that the straightening at Site 4b occurred prior to this date. There has been significant straightening downstream of Brigsley since 1907, along with the straightening of the length immediately upstream of Site 4b.

- 11.6.2 Turbidity was high during the survey indicating the presence of fine sediment, with likely input from adjacent agricultural land use and the local road network. Although this length of watercourse had been modified, it still displayed pool riffle sequences. The bed was comprised of cobbles and larger gravels overlain by silty deposits in many parts. Artificial bank reinforcement was present upstream of the B1203 road crossing. Downstream of the road crossing, the banks were approximately 1.2 m high, with the right bank forming a raised embankment disconnecting the watercourse from the floodplain. The banks were vegetated with grasses and herbs, with some trees on the left bank.

*Photograph 11-17: Waithe Beck (Site 4b) View Upstream*

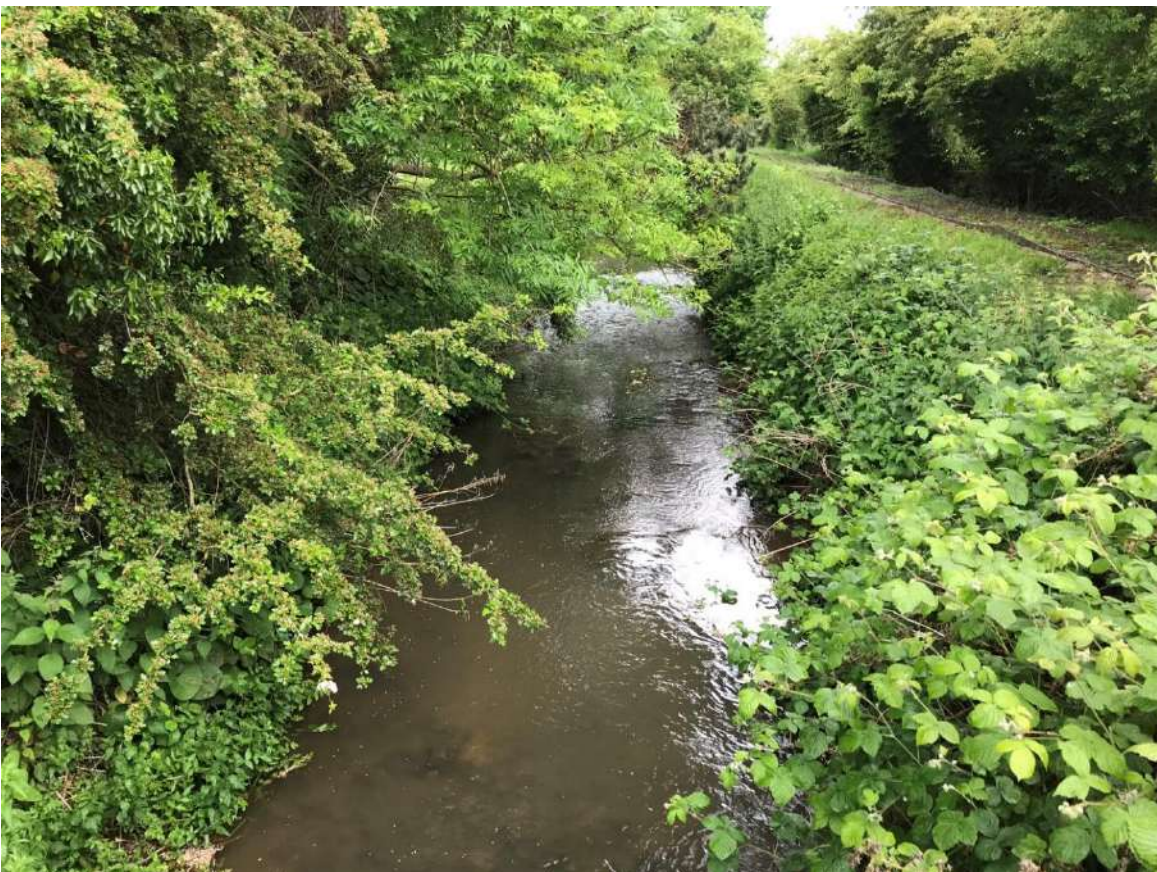
*Photograph 11-18: Waithe Beck (Site 4b) View Downstream*

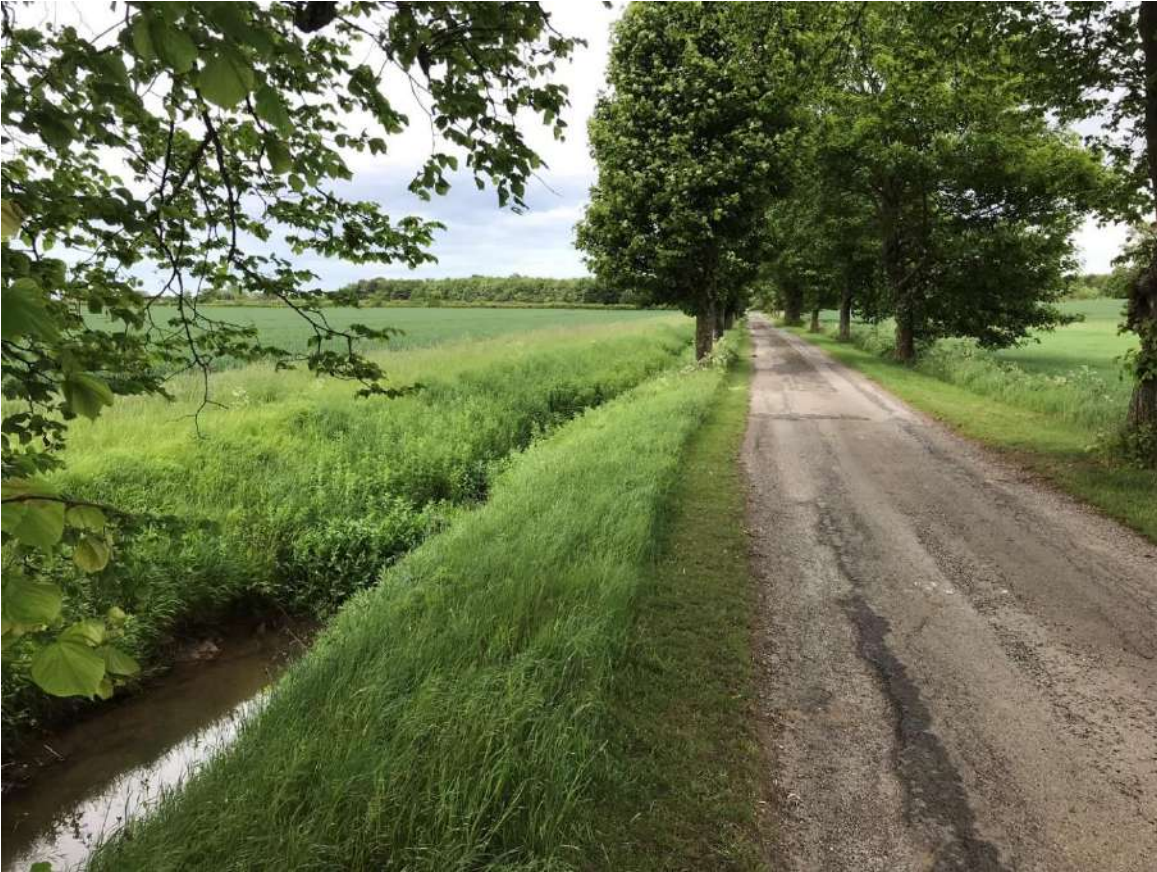
- 11.7.1 Black Leg Drain follows the same course as was indicated on the 1907 OS mapping, suggesting any modifications occurred prior to this date.
- 11.7.2 Black Leg Drain through this length comprised a straightened channel bordered by a narrow access road set within flat, open, agricultural land. The bed was silty and occasionally vegetated with willowherb, with heavier willowherb growth at the channel margins. The steep banks were approximately 1.8 m high and vegetated with grasses. Minor localised sinuosity driven by vegetation growth had developed, with vegetation providing minor variation in flow types. The bank tops were primarily comprised of grasses, with the access road also being present on the right. Some planted trees were present on the right bank top, spaced at approximately 10 m intervals.

***Photograph 11-19: Black Leg Drain (Site 6a) View Downstream***

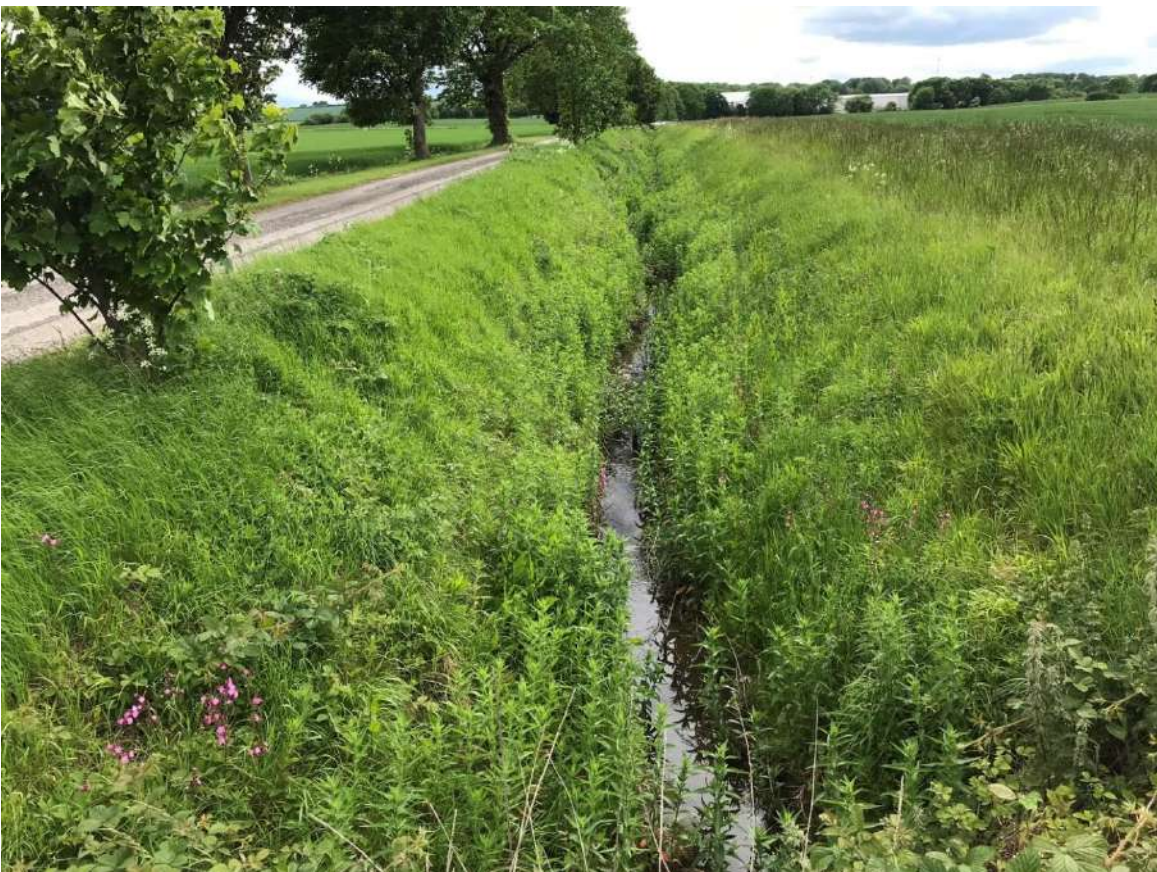
***Photograph 11-20: Black Leg Drain (Site 6a) View Upstream***

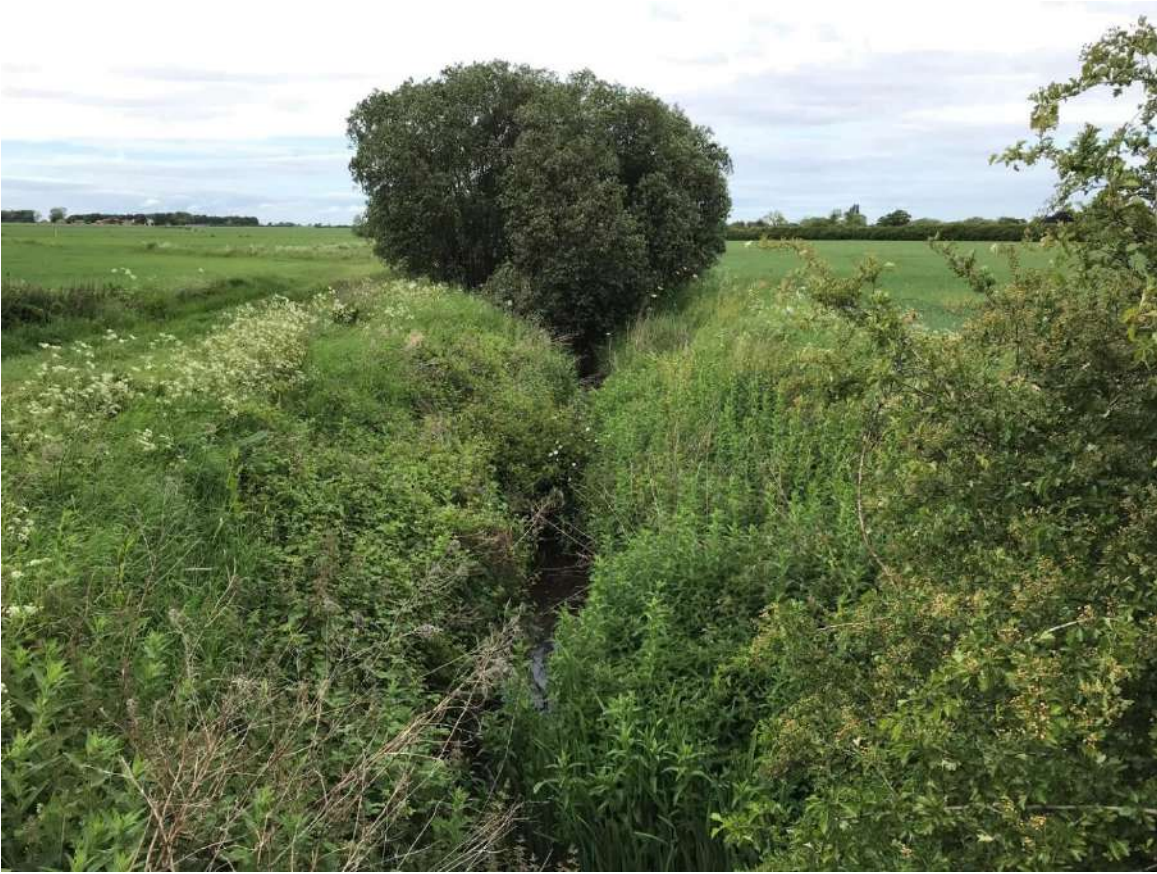
- 11.8.1 According to historic OS mapping dating from 1907, there have been no significant modifications to the planform of Poulton Drain since this date, apart from the creation of a pond upstream of Site 7a near Ings Lane which appears to be formed from a small impounding structure on the watercourse. A review of aerial imagery indicated that this pond may not always be fully wetted. There also appears to be another small impounding structure further upstream.
- 11.8.2 Poulton Drain was set within an area of flat agricultural land. The watercourse had steep banks of approximately 2 m height, disconnecting it from the floodplain. The bed was heavily vegetated in parts, with reeds and herbs occupying much of the width and having a direct impact on flow. The banks were vegetated with herbs and grasses, with lone trees present in parts. The bed appeared to be silty and flow was pooled.

***Photograph 11-21: Poulton Drain (Site 7a) View Downstream***

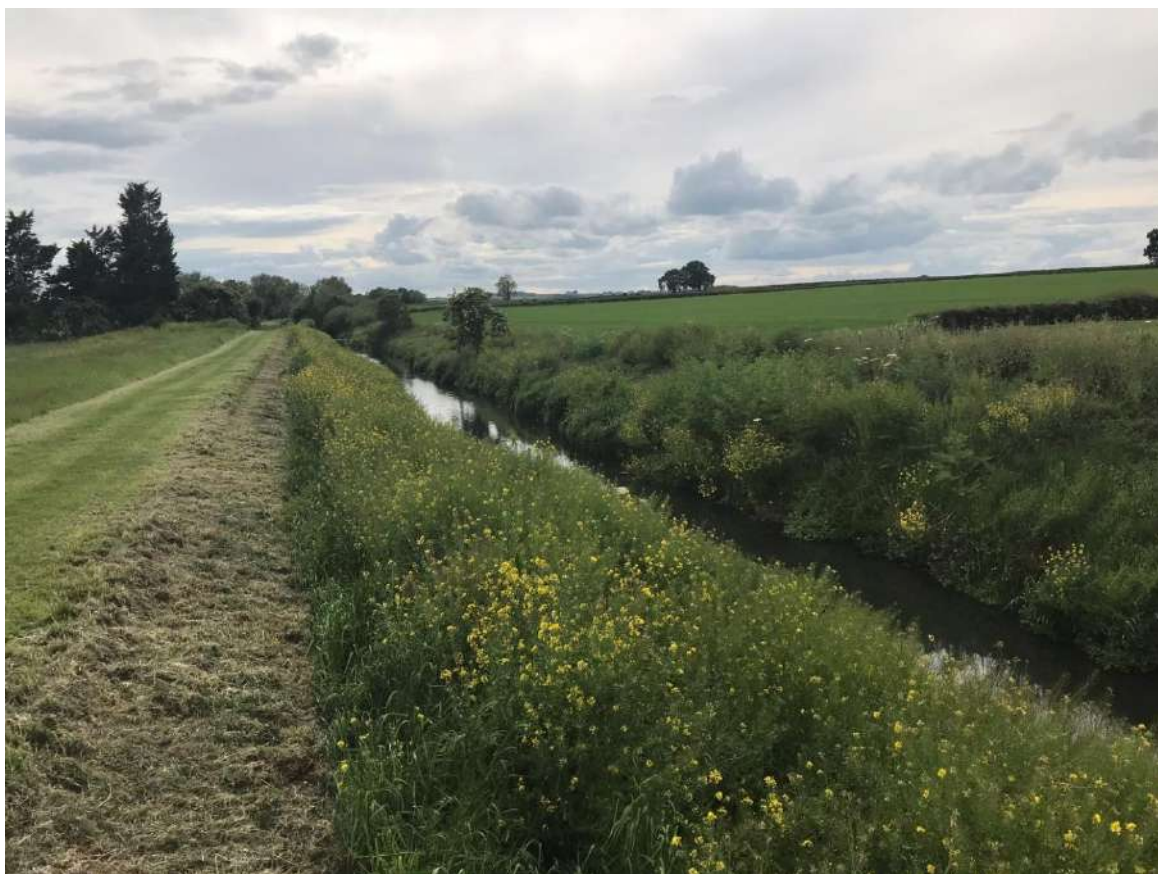
11.10.4 The Louth Canal appears to be an artificial water body which generally follows the course of the River Ludd through this area. The canal was straight with a uniform cross section. The bed was heavily vegetated with submerged broadleaved macrophytes, with some reed growth at the channel margins. Flow was generally smooth and laminar or there was no perceptible flow. Since the canal is artificial and low energy, it is assumed that the bed would likely be silty. The banks were steep and approximately 1.5-2 m high, and were vegetated with grasses and herbs. A narrow tree line was also present on the left bank and bank top.

***Photograph 11-23: Louth Canal (Site 9a) View Upstream***

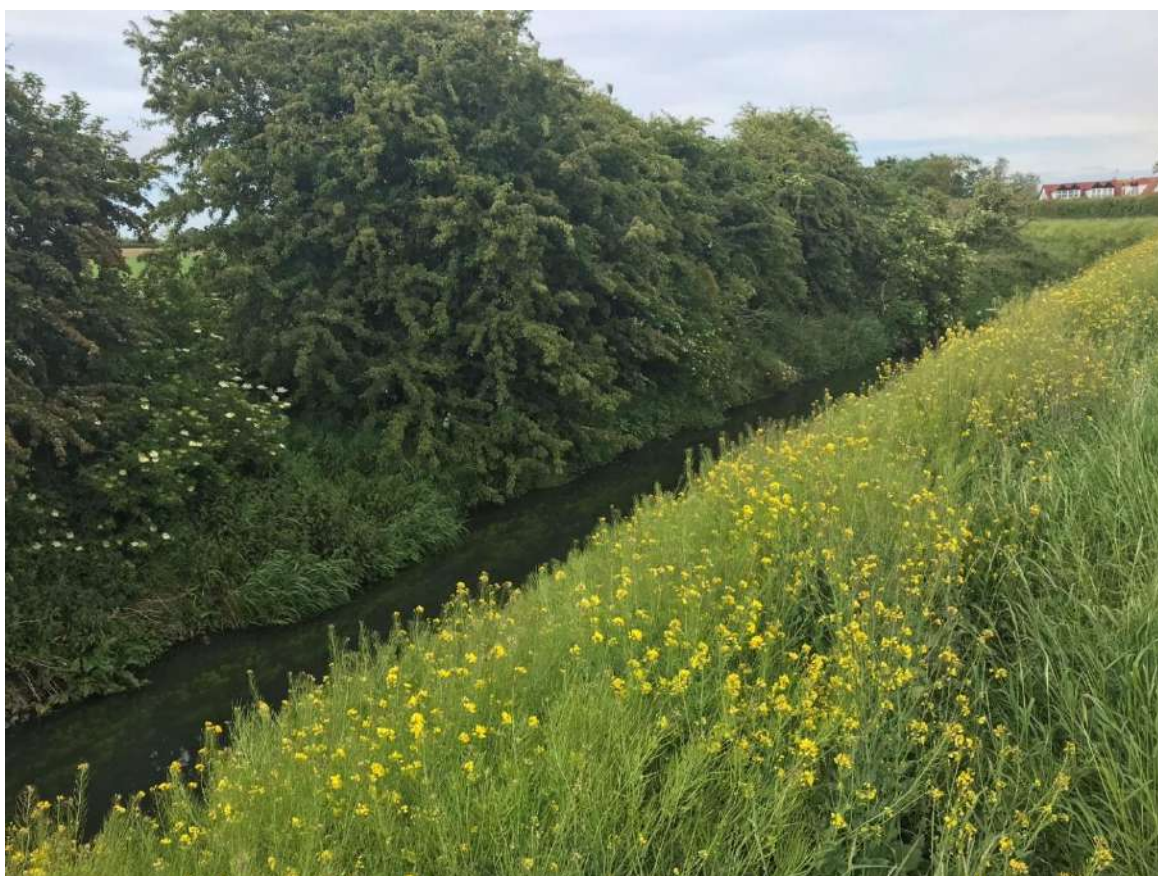
***Photograph 11-24: Louth Canal (Site 9a) View Downstream***
