Viking CCS pipeline

# Preliminary Environmental Information Report Volume IV

Appendix 11.2

# Site Visit Technical Note

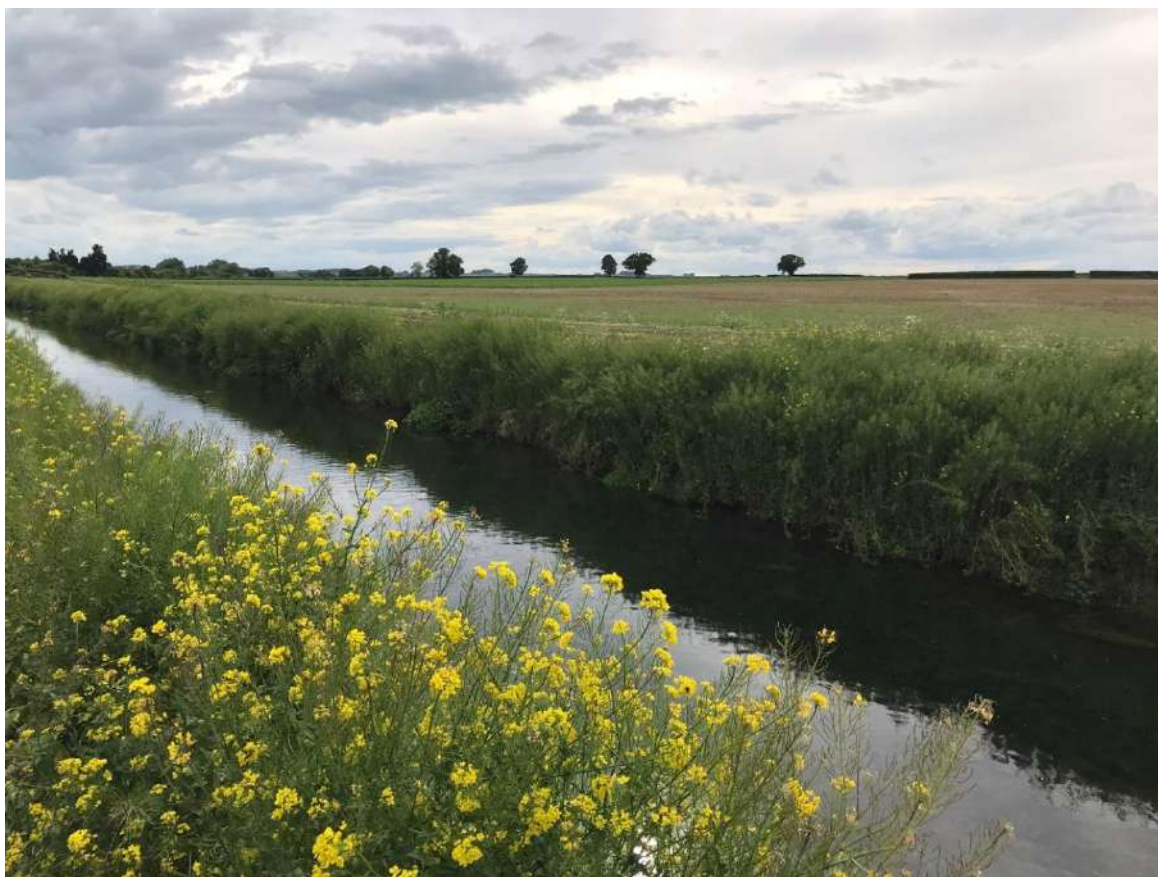
11.10.5 Site 9b is of the same character as Site 9a, although the presence of trees on the left bank was now gone.

***Photograph 11-25: Louth Canal (Site 9b) View Upstream***

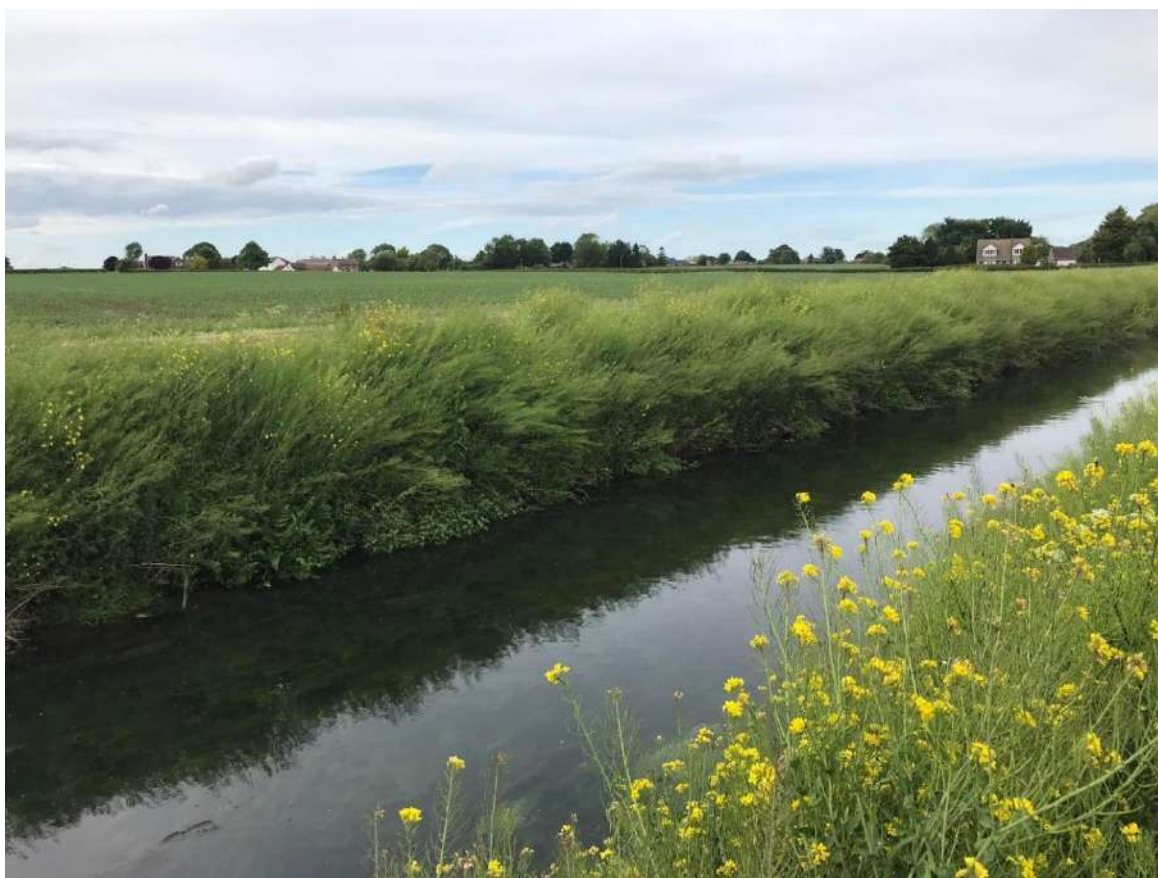
***Photograph 11-26: Louth Canal (Site 9b) View Downstream***

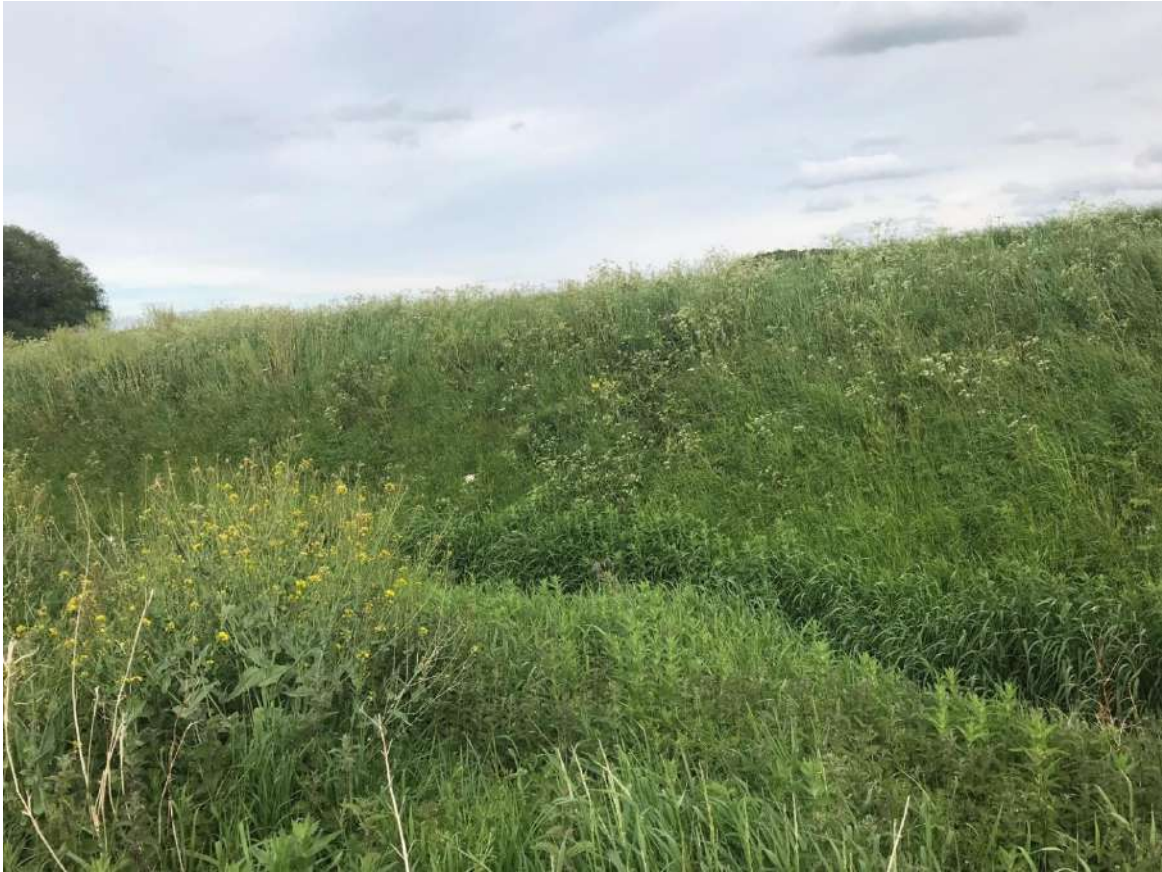
11.11.4 Vegetation prevented access directly to the watercourse to observe the bed. A large embankment of approximately 3 m height was present on the right bank. Bank vegetation was mostly comprised of grasses and herbs. Bank vegetation was overhanging and shading the channel.

***Photograph 11-27: River Ludd (Site 10a) View of Channel***

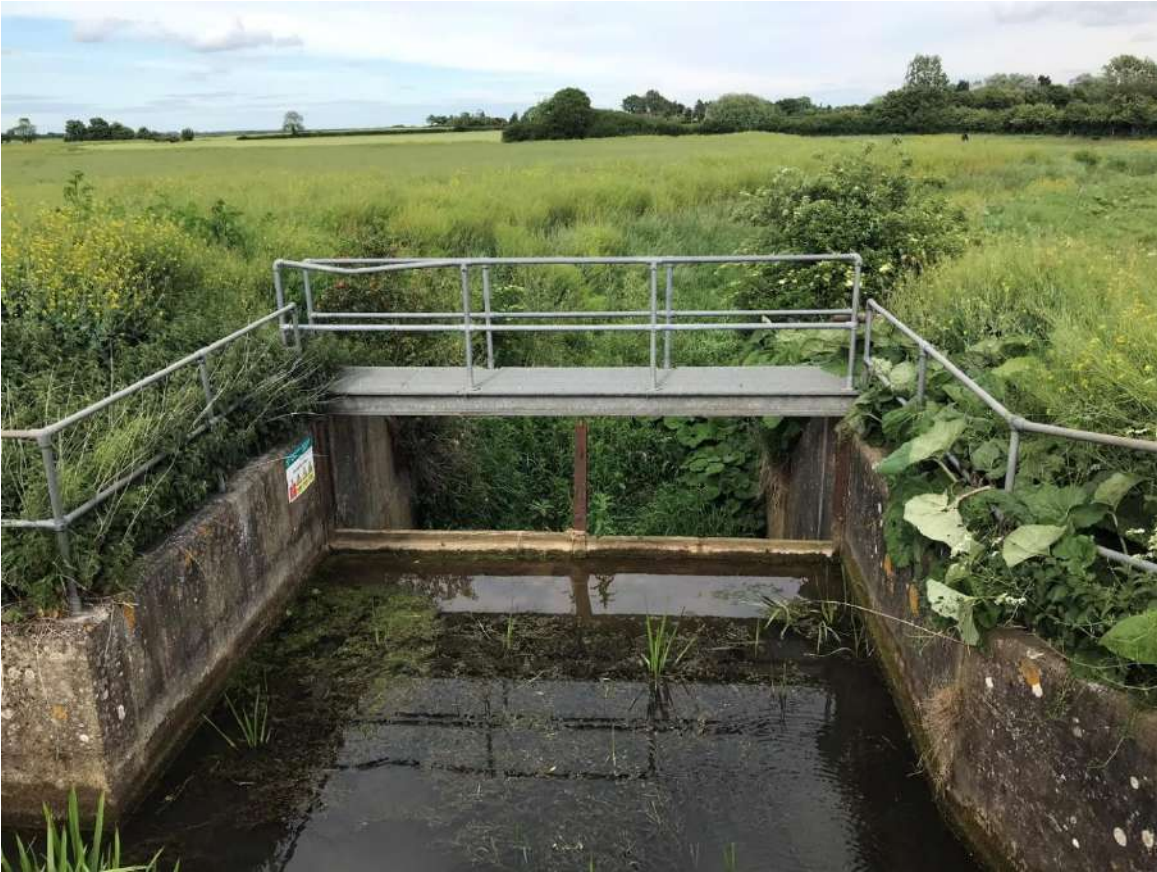
11.11.5 Access to Site 10b was not possible so the watercourse was viewed further downstream at the crossing of Lock Road. A sluice weir was present at this location impounding flow upstream of it. The watercourse had been straightened in this location, with palaeomeanders visible on aerial imagery on the left floodplain upstream of the road crossing. A linear channel is connected on the left bank at the sluice weir which appears to be connected to the Louth Canal, and likely takes water from the River Ludd to the canal. This sluice weir and offtake channel resulted in little water being present in the channel downstream. The banks were approximately 1.5-2 m high and vegetated with grasses and herbs. Linear reeds were growing at the channel margins and shading the channel. Surrounding land use was agricultural fields.

***Photograph 11-28: River Ludd (Site 10b) Sluice Structure***

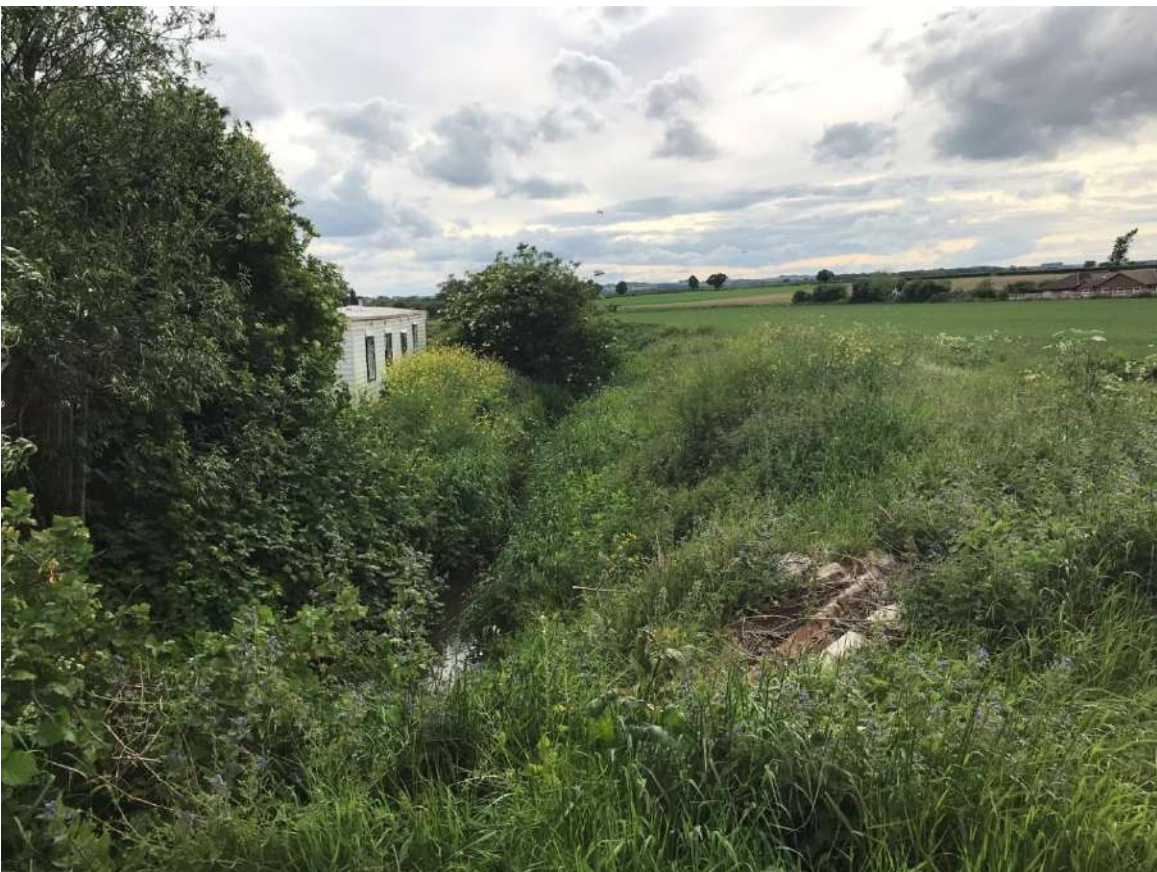
***Photograph 11-29: River Ludd (Site 10b) View Upstream***

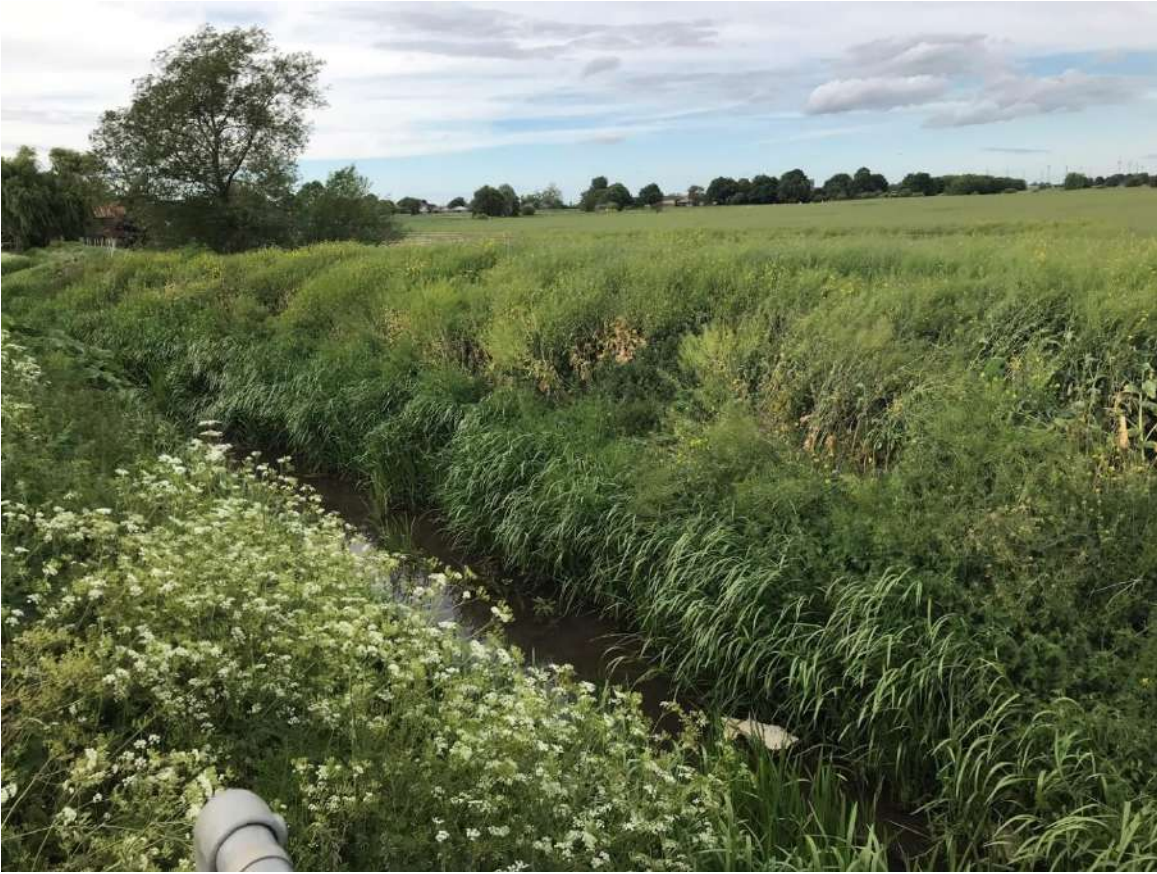
*Photograph 11-30: River Ludd (Site 10b) View Downstream*

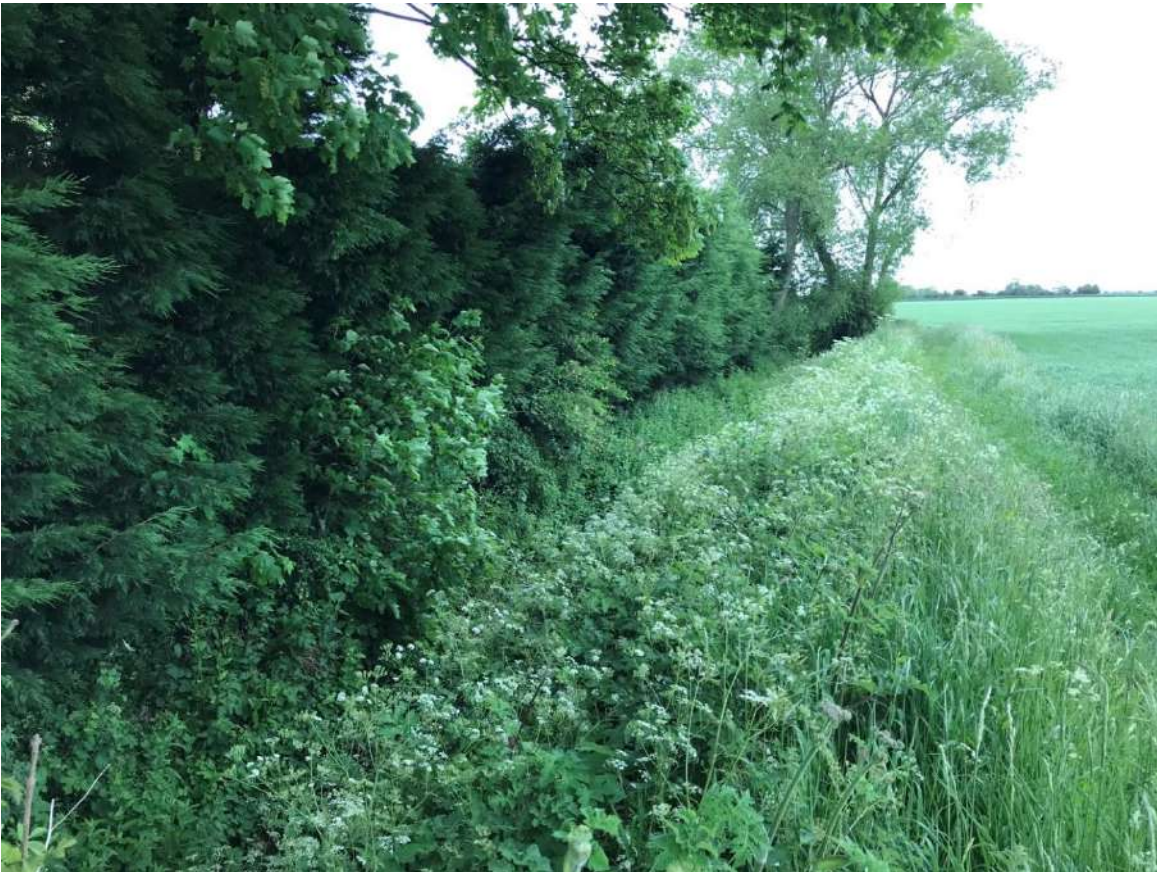
11.12.3 Green Dike through this length was formed of a small linear drain set within flat agricultural fields and bordered by a narrow strip of woodland. There was very little flow at the time of survey, with some parts being dry and shallow standing water being present elsewhere. The bed was silty. The banks were shallow, approximately 0.3-0.5 m high, and vegetated with herbs, grasses, shrubs, and trees.

***Photograph 11-32: Green Dike (Site 11a) View Downstream***

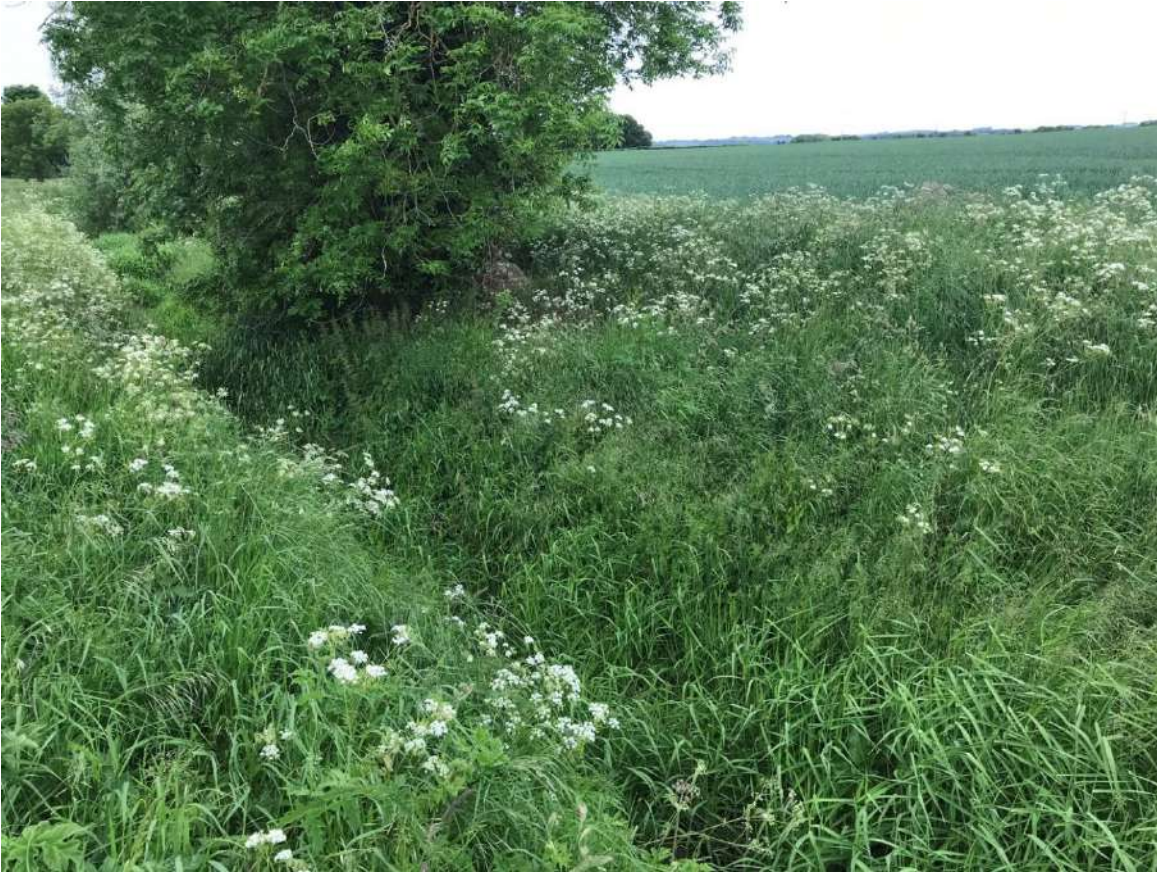
11.12.4 Green Dike at this site displayed a similar character to Site 11a, although it was no longer bordered by woodland and the channel bed was vegetated with reeds and some other herbs and grasses. The banks were also steeper and higher through this length, being up to approximately 1 m in height.

***Photograph 11-33: Green Dike (Site 11b) View Upstream***

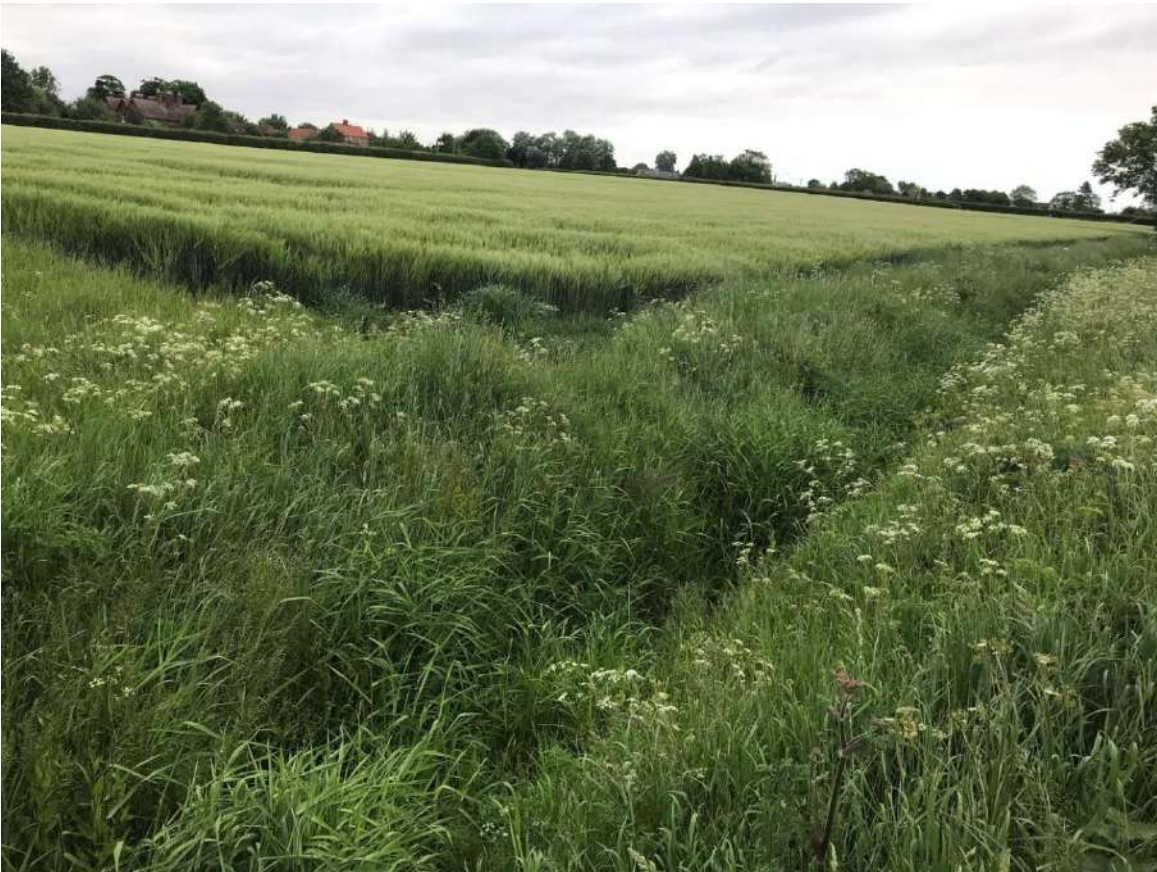
***Photograph 11-34: Green Dike (Site 11b) View Downstream***

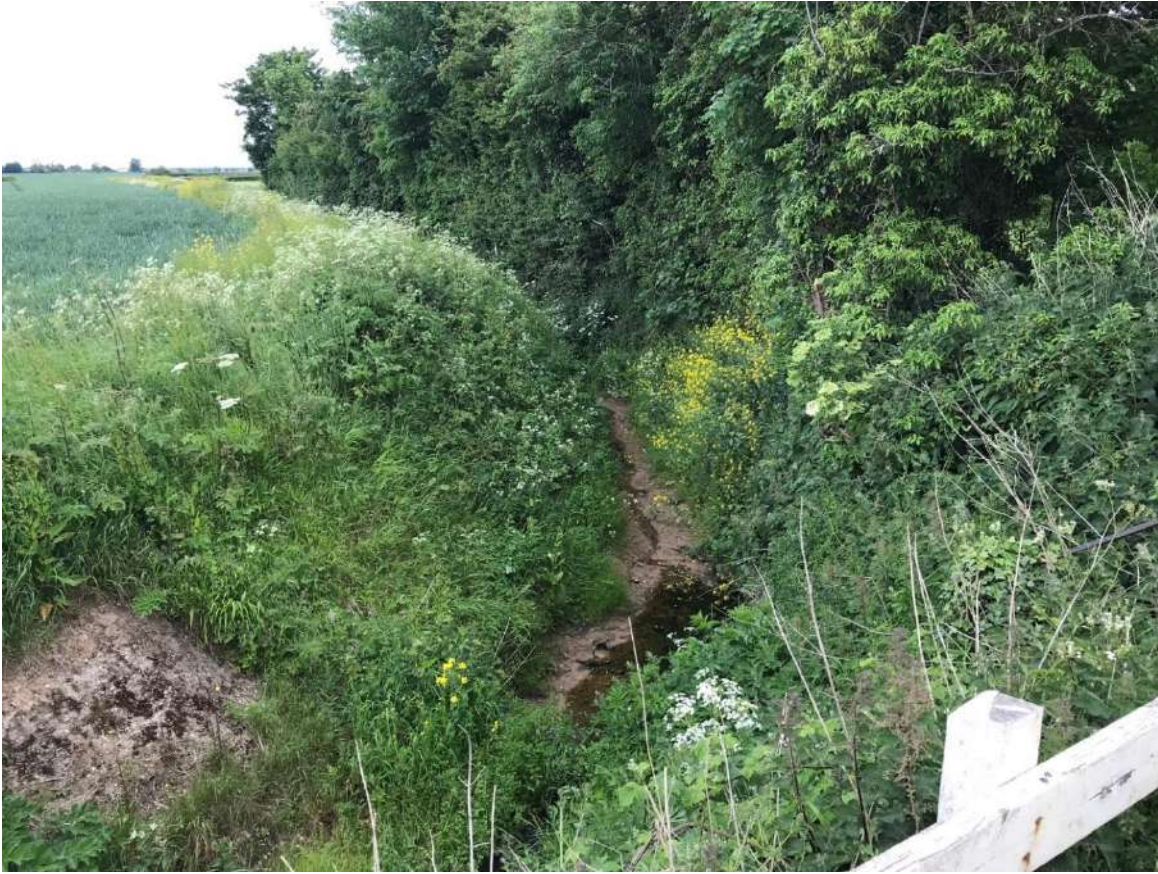
11.13.2 Harrowsea Drain comprised a small agricultural drain. It was mostly dry at the time of survey, with a small trickle of water and some standing water in parts. Bed substrate was comprised of silt. The banks were approximately 0.5-1.5 m high, With the left bank generally being higher. The left bank was vegetated with grasses and herbs while the right bank vegetation comprised grasses, herbs, shrubs and trees.

***Photograph 11-35: Harrowsea Drain (Site 12b) View Downstream***

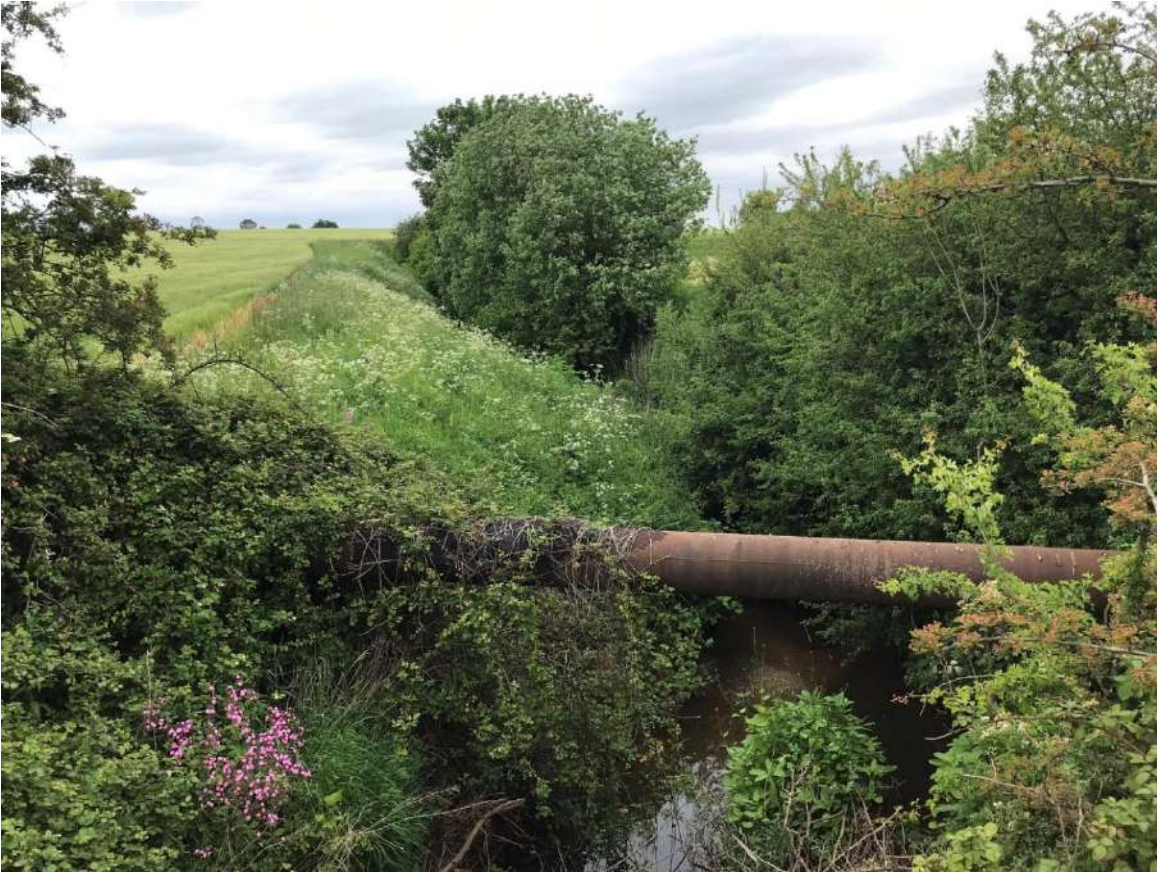
11.14.2 The watercourse was heavily incised, with banks of approximately 4-5 m height completely disconnecting the watercourse from the surrounding land. Although the bed appeared to be silty and the water quite turbid, a small mid-channel gravel deposit was visible suggesting that there may be gravels underlying the silt. Bank vegetation was comprised of grasses and herbs, with trees present on the right bank. Surrounding land use comprised agricultural fields. An existing pipe crossing was present at this site.

***Photograph 11-36: Grayfleet Drain (Site 13b) View Downstream***

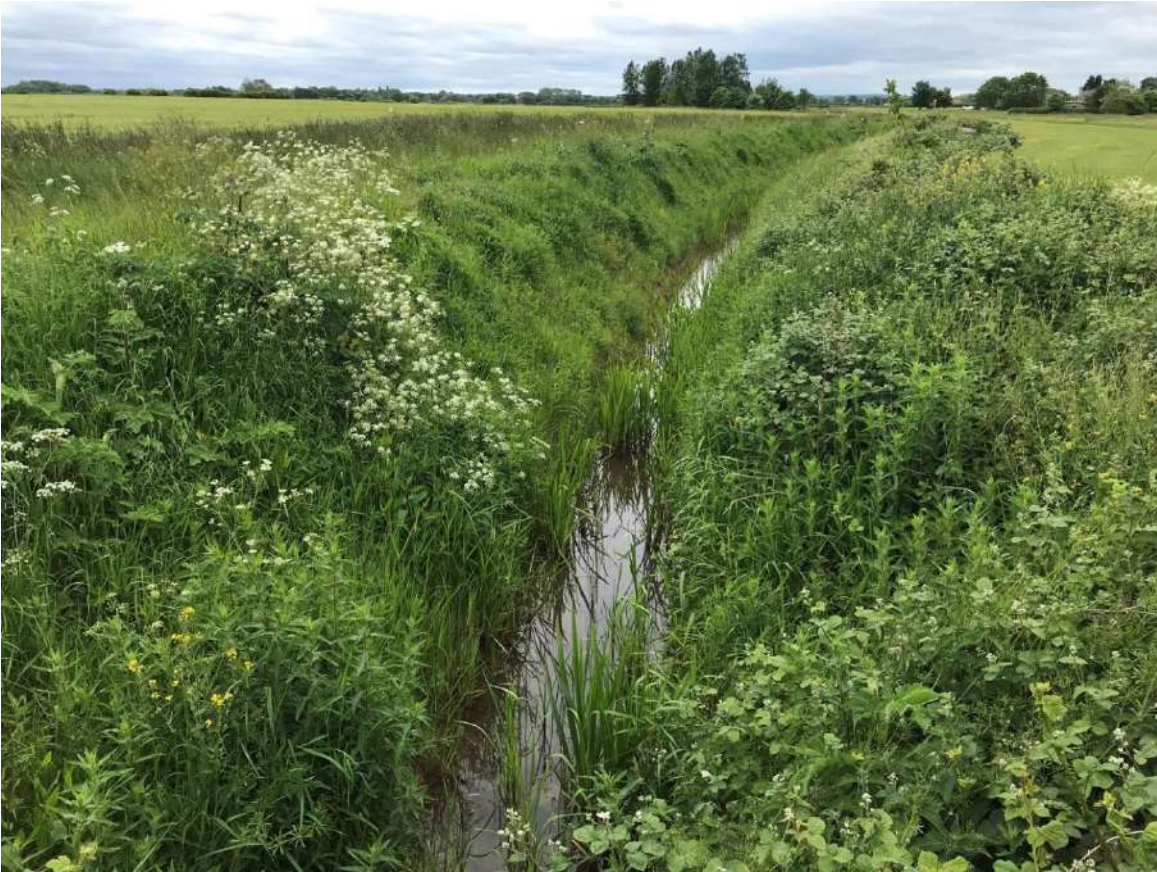
11.15.2 Sykes Drain appeared to have been heavily modified for agricultural drainage with banks being steep and approximately 2 m high upstream of the Willow Row Bank road crossing. The banks were steep downstream of the road crossing but were only approximately 1.5 m high. Water was present within the channel but there was no perceptible flow. The bed was quite heavily vegetated with reeds and appeared to be silty. Approximately 20 m downstream of the site work had taken place on the channel, with both the bed and banks being stripped of vegetation.

***Photograph 11-37: Sykes Drain (Site 14b) View Upstream***

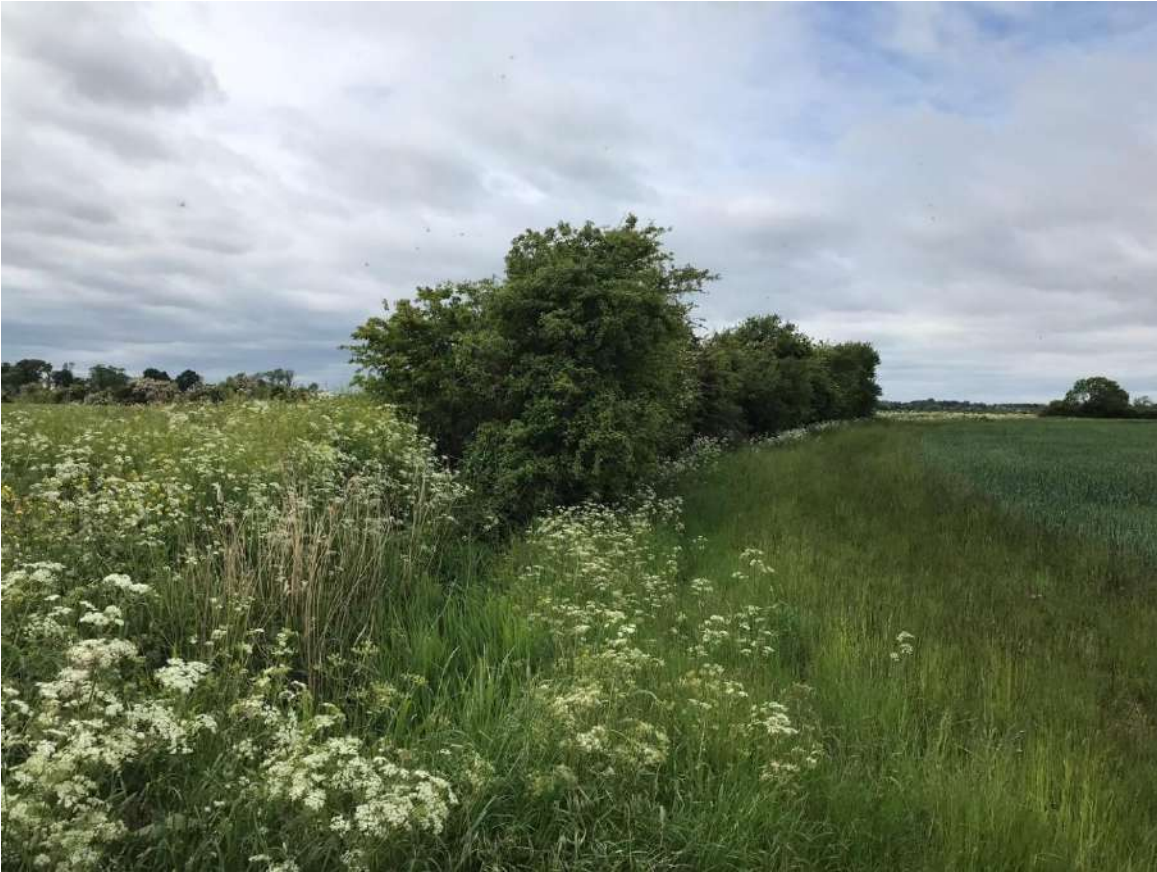
11.16.2 Head Dike Drain was a linear field drain. The channel itself could not be observed fully due to dense vegetation. Reeds, grasses and herbs, and some trees were growing within and adjacent to the channel. Surrounding land was flat agricultural fields.

*Photograph 11-39: Head Dike Drain (Site 15) View Upstream*

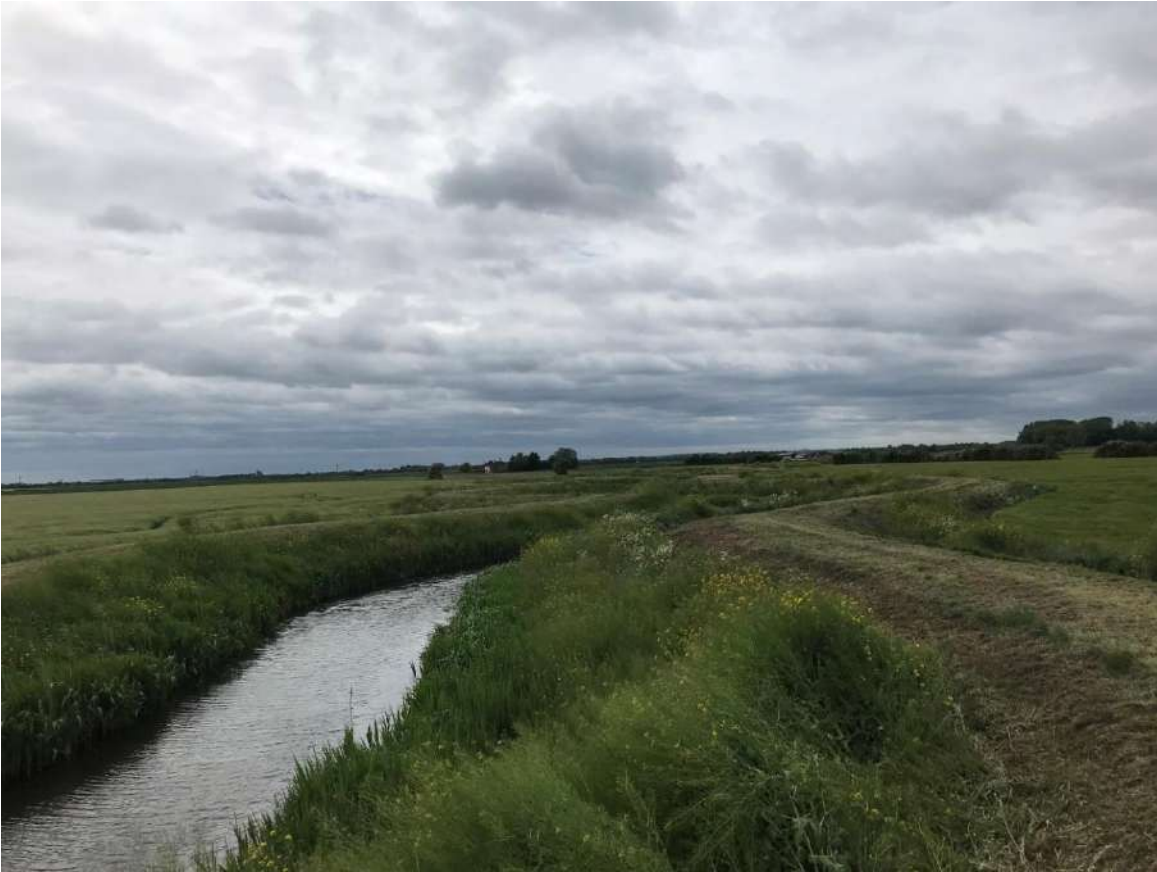
11.17.2 The watercourse was observed where it flows adjacent to Willow Row Bank. Although it displays a more natural sinuous planform, the watercourse has still been modified with embankments on either side disconnecting it from its floodplain. The low energy nature of the watercourse coupled with embankments mean that the watercourse cannot remeander itself through the lengths that have been straightened. There was abundant reed growth at the channel margins. Bed substrate could not be observed. Surrounding land was flat agricultural fields.

***Photograph 11-41: Long Eau (Site 16b) View Upstream***

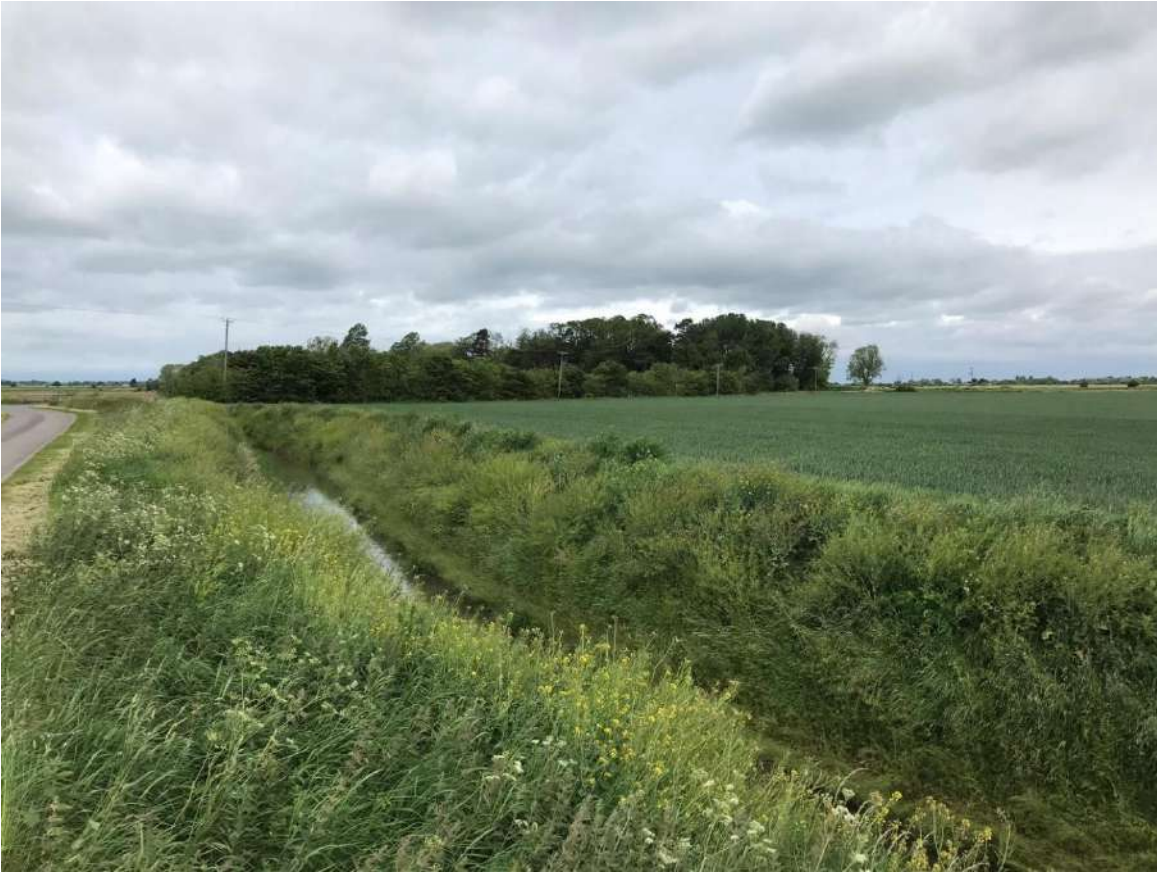
11.18.2 The drain was quite large at approximately 4 m bankfull width. The banks were steep and high (approximately 2 m) and vegetated with grasses and herbs. There was some marginal reed growth, and other submerged macrophytes appeared to be growing on the channel bed. Turbidity was quite high indicating the presence of fine sediment. The bed was not visible so substrate could not be observed, although it is assumed that it would likely be silty due to the high turbidity, slow flow and general low gradient, low energy conditions. A small road bordered the drain on one side, with agricultural fields on the other.

***Photograph 11-43: The Cut (Site 17a) View Upstream***

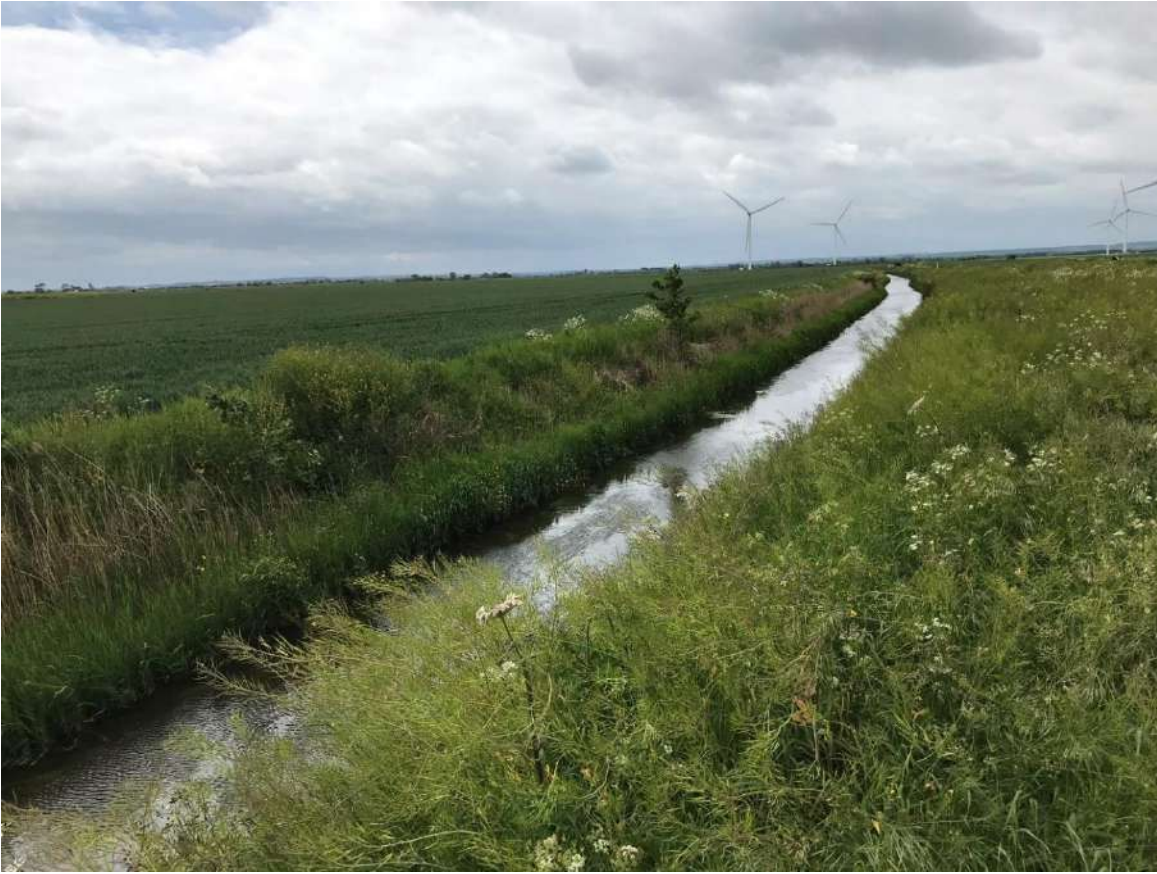
11.20.2 Old Engine Drain is also part of the same linear network of drainage channels as the previous two sites. The drain displayed a similar character to The Cut Drain, with a similar bank profile and height. As with The Cut Drain, reeds were abundant at the channel margins, and submerged macrophytes were present on the bed. Turbidity was quite high, and as with the previous site, the bed was likely to be silty.

***Photograph 11-47: Old Engine Drain (Site 21b) View Upstream***

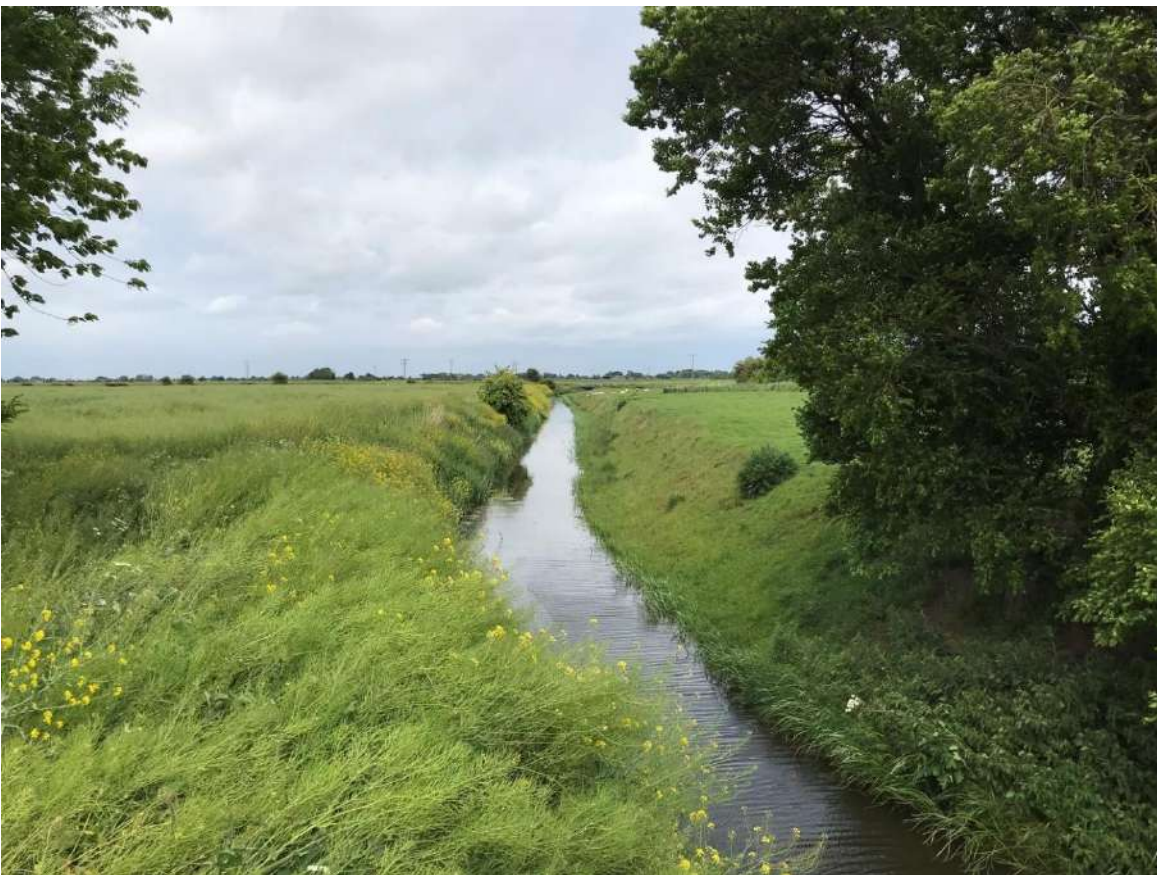
***Photograph 11-48: Old Engine Drain (Site 21b) View Downstream***

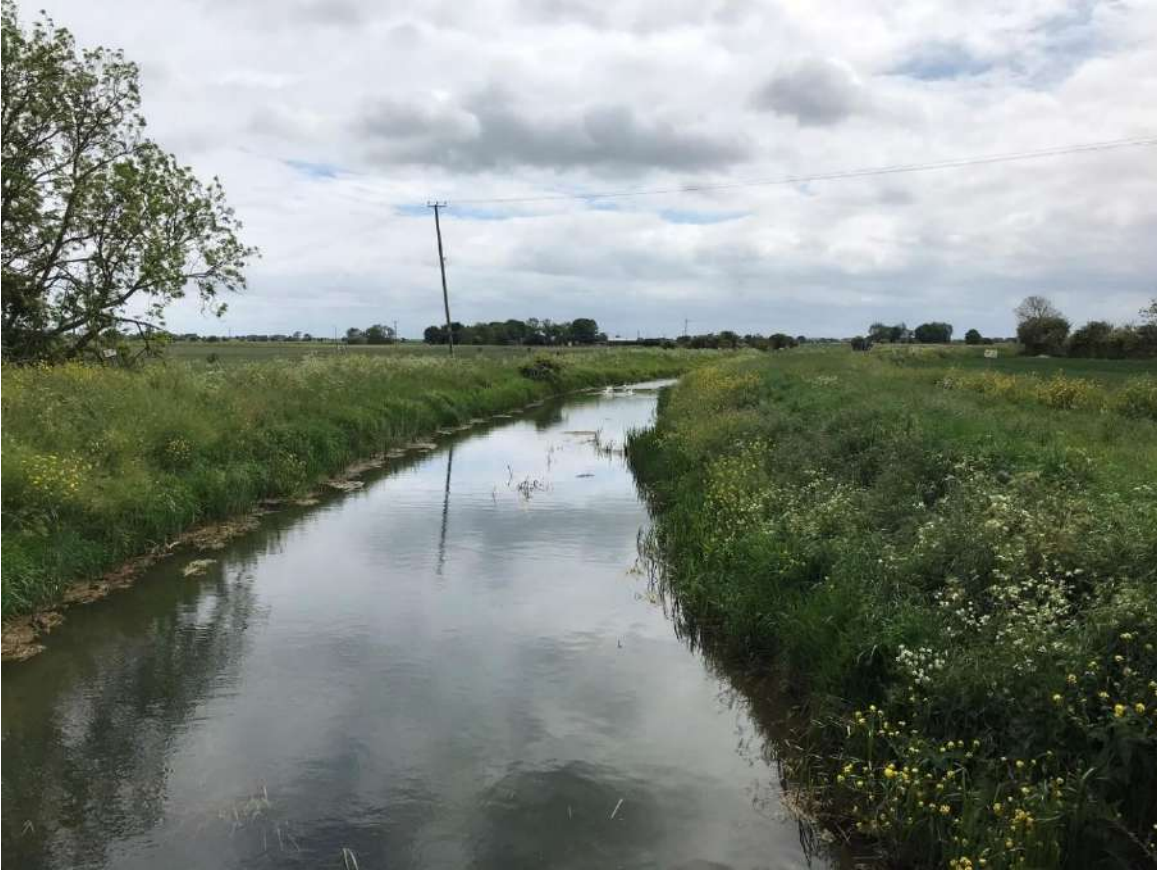
11.21.2 The Great Eau comprised a channel of approximately 6-8 m bankfull width, with banks of approximately 2 m height. The bed was silty and sandy, and heavily vegetated with submerged linear leaved macrophytes. Flow was smooth and the water very clear. Channel margin vegetation consisted of reeds, while the banks were vegetated with grasses and herbs. Some reed growth was also observed on the channel bed. Surrounding land use was flat agricultural fields.

***Photograph 11-49: Great Eau (Site 22b) View Upstream***
