Viking CCS pipeline

# Preliminary Environmental Information Report Volume IV

Appendix 11.2

# Site Visit Technical Note

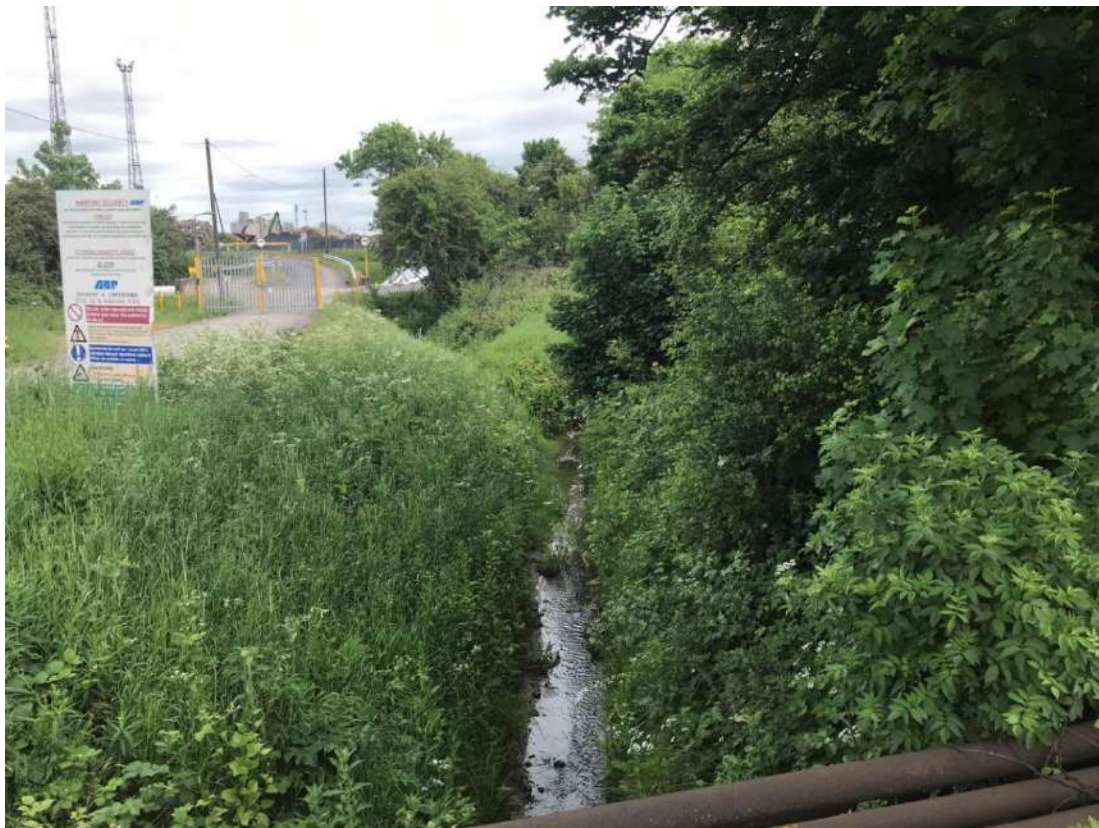
**Photograph 11-2: Harborough Marsh Drain (Site 1a) View Downstream**

11.3.4 The watercourse was surveyed at the existing Manby Road crossing to the north of Immingham. The watercourse flowed through an area of flat land and was bordered by agricultural fields and industrial units. The watercourse has been significantly modified for drainage, having been straightened, deepened and widened. As a result, the watercourse displays no morphological diversity, and the straight trapezoidal channel provides little opportunity to provide quality habitat. The steep banks were

approximately 2 m high and vegetated with grasses, with some scattered trees present. The bed was primarily comprised of silt.

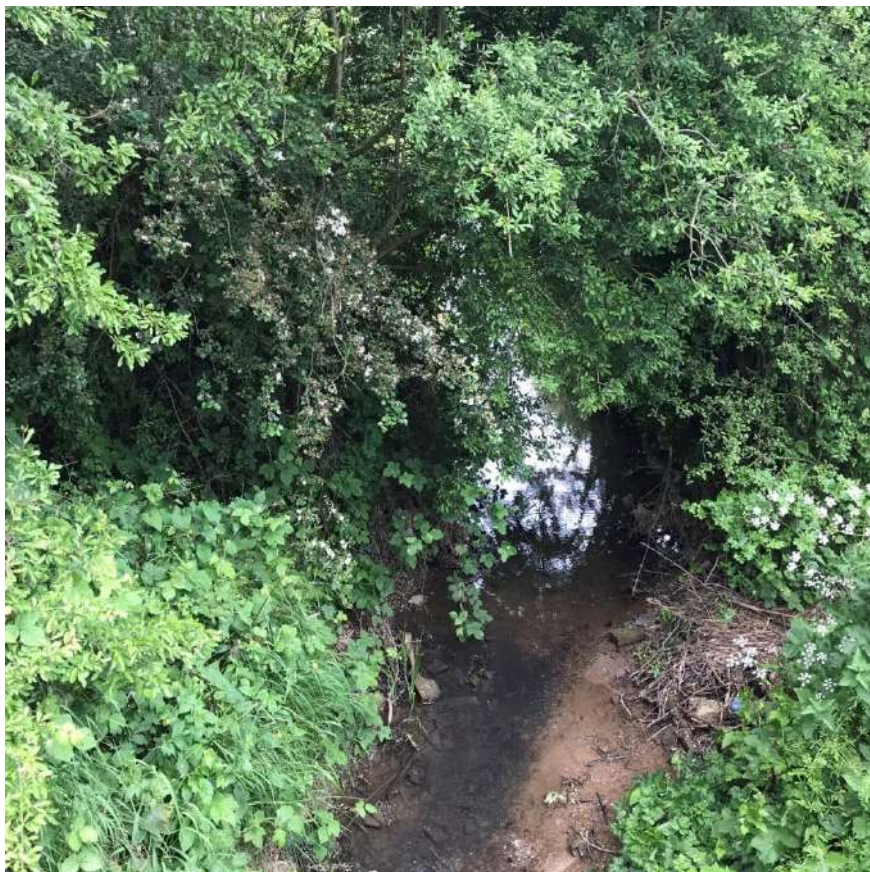
*Photograph 11-7: Harborough Marsh Drain tributary (Site 1f) View Upstream*

11.3.7 The watercourse at Site 1f was again a different watercourse connected to the drains detailed previously. The site is located at the existing Mill Lane crossing. The watercourse was heavily modified as was seen at the previous sites, with a similar cross section. Some coarser material on the bed did, however, provide some minor flow variation, although the channel was largely devoid of morphological features.

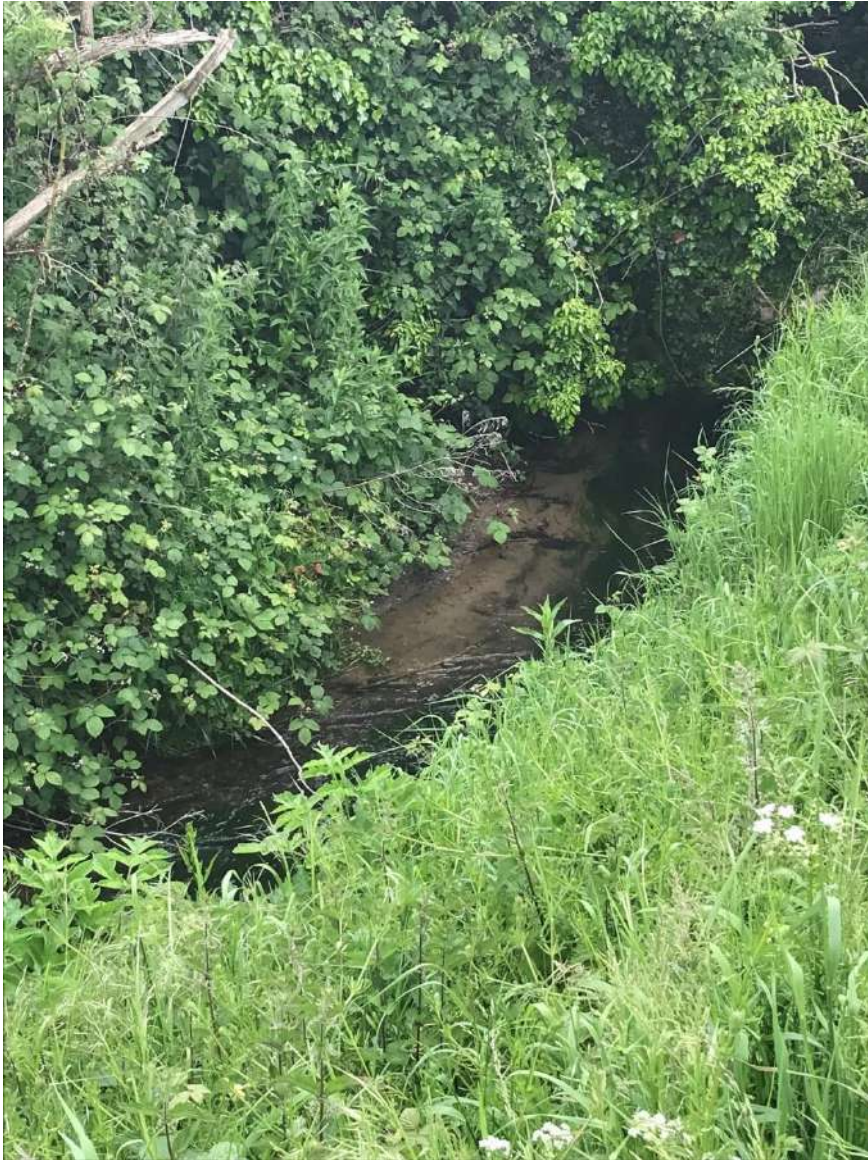
***Photograph 11-12: North Beck Drain (Site 2) View Downstream***

- 11.4.1 Site 2 is located on a straightened length of North Beck Drain, within an area of flat agricultural land. The watercourse planform has remained largely unchanged since 1908 according to historic OS mapping, although some straightening has occurred a short distance upstream of Site 2. The straightening of the length at Site 2 evidently occurred prior to 1908.

- 11.4.2 The channel was incised, disconnecting it from the surrounding land, with banks of approximately 2 m height. The channel was devoid of morphological diversity through this straightened length, and was characterised by laminar gliding flow. Bed substrate was predominantly silt and turbidity was quite high. A short distance upstream of Site 2 the watercourse displays a more natural sinuous planform. Morphological and flow diversity are much greater through this sinuous length, with embryonic riffles and bars present along with a variety of flow types. Both banks were predominantly vegetated with long grasses and herbs, with some scrub present in parts. The riparian zone on the left was wooded with a narrow strip of dense tree cover.

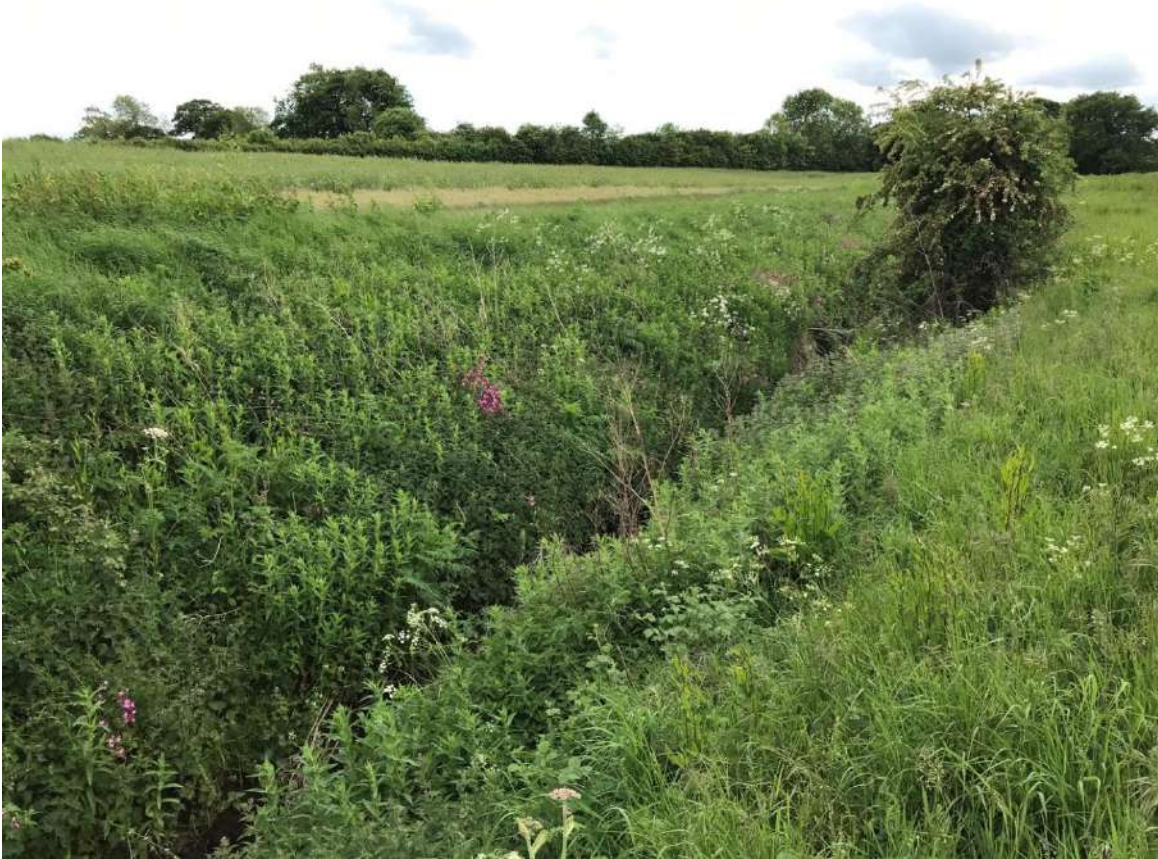
***Photograph 11-22: Yarburgh Beck (Site 8b) View Upstream***

- 11.9.1 Yarburgh Beck has been straightened near to Site 8b, including straightening immediately downstream of the site which has occurred after the 1907 OS mapping was published.
- 11.9.2 Through this length Yarborough Beck displayed a similar character as many of the watercourses in this area. Adjacent land was flat and was comprised of agricultural fields. The watercourse had steep banks of approximately 1.5-2 m height, disconnecting it from the floodplain. The banks were vegetated with herbs and grasses with occasional trees. Some herb growth was present on the channel bed and margins. The bed appeared to be silty.

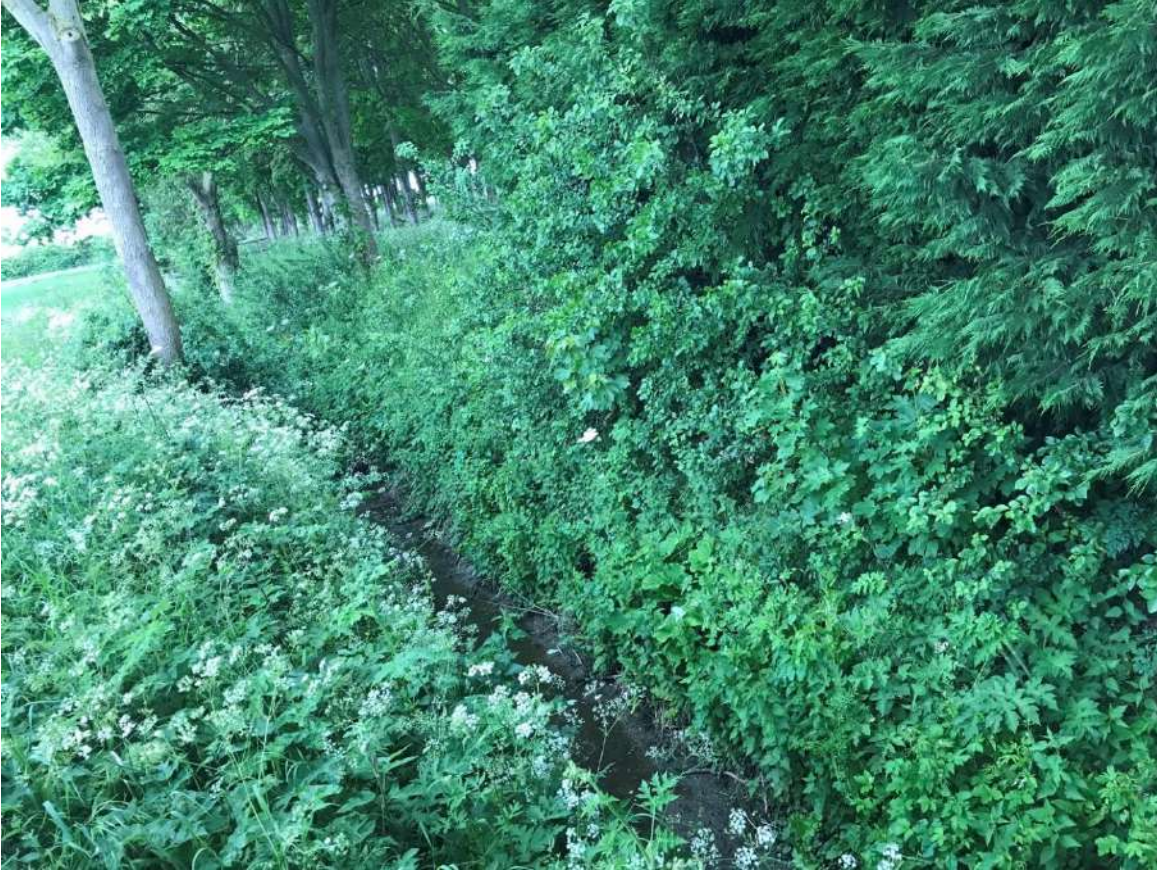
***Photograph 11-31: Green Dike (Site 11a) View Upstream***

11.12.3 Green Dike through this length was formed of a small linear drain set within flat agricultural fields and bordered by a narrow strip of woodland. There was very little flow at the time of survey, with some parts being dry and shallow standing water being present elsewhere. The bed was silty. The banks were shallow, approximately 0.3-0.5 m high, and vegetated with herbs, grasses, shrubs, and trees.

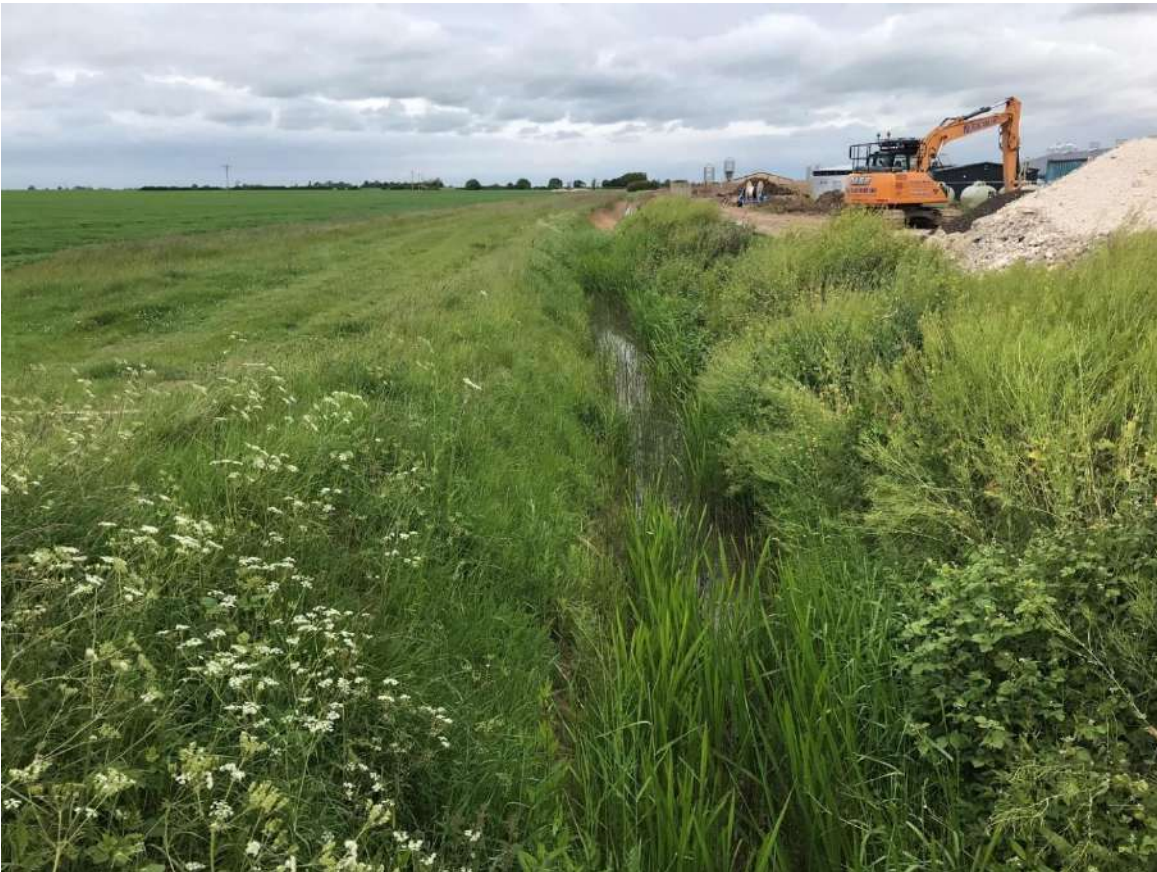
***Photograph 11-38: Harrowsea Drain (Site 12b) View Downstream***

11.13.2 Harrowsea Drain comprised a small agricultural drain. It was mostly dry at the time of survey, with a small trickle of water and some standing water in parts. Bed substrate was comprised of silt. The banks were approximately 0.5-1.5 m high, With the left bank generally being higher. The left bank was vegetated with grasses and herbs while the right bank vegetation comprised grasses, herbs, shrubs and trees.

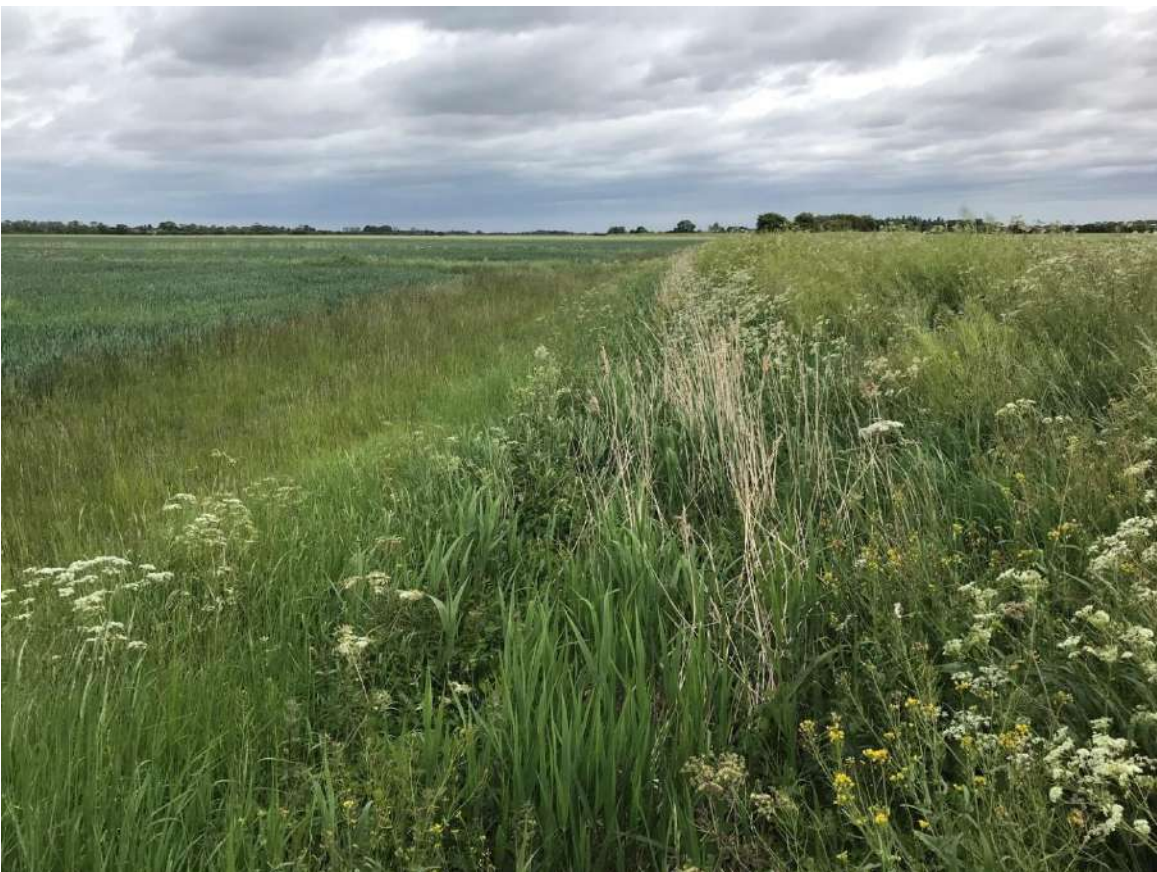
*Photograph 11-40: Head Dike Drain (Site 15) View Downstream*

11.16.2 Head Dike Drain was a linear field drain. The channel itself could not be observed fully due to dense vegetation. Reeds, grasses and herbs, and some trees were growing within and adjacent to the channel. Surrounding land was flat agricultural fields.

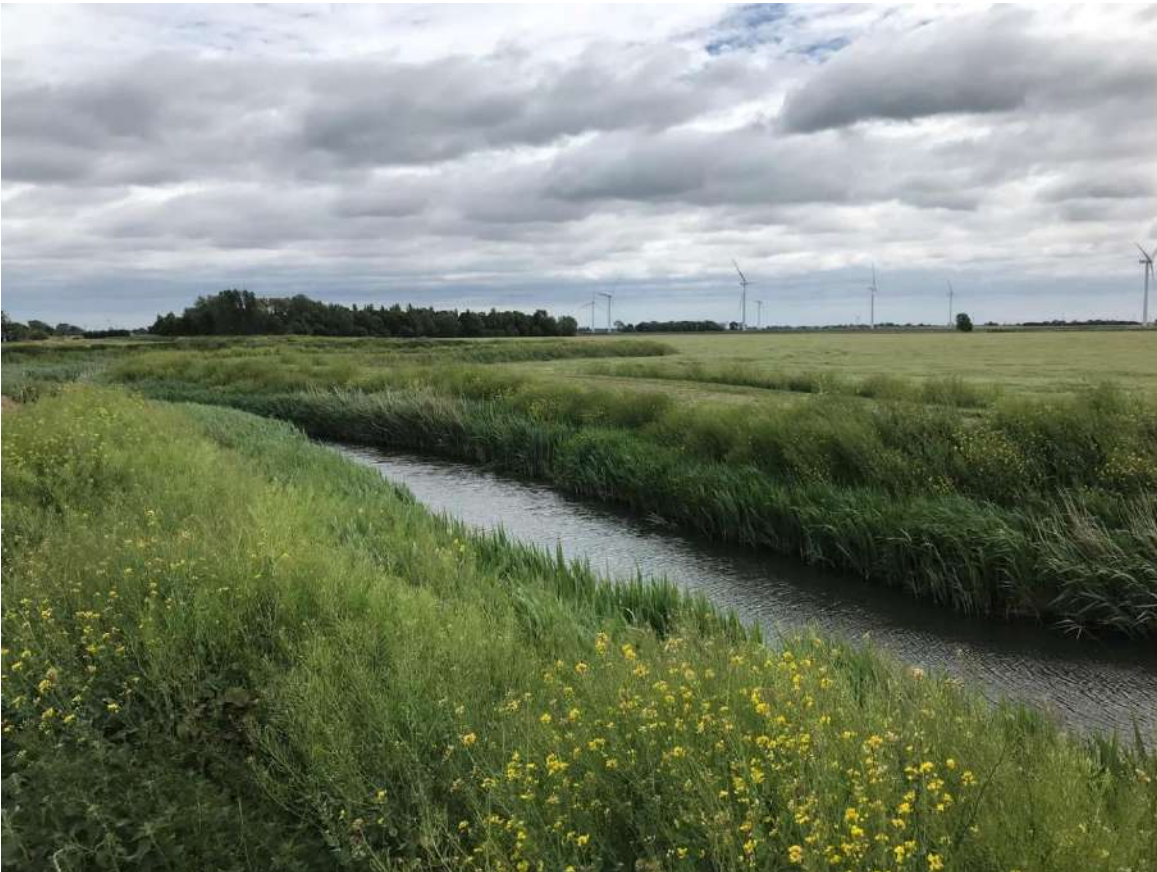
***Photograph 11-42: Long Eau (Site 16b) View Downstream***

11.17.2 The watercourse was observed where it flows adjacent to Willow Row Bank. Although it displays a more natural sinuous planform, the watercourse has still been modified with embankments on either side disconnecting it from its floodplain. The low energy nature of the watercourse coupled with embankments mean that the watercourse cannot remeander itself through the lengths that have been straightened. There was abundant reed growth at the channel margins. Bed substrate could not be observed. Surrounding land was flat agricultural fields.

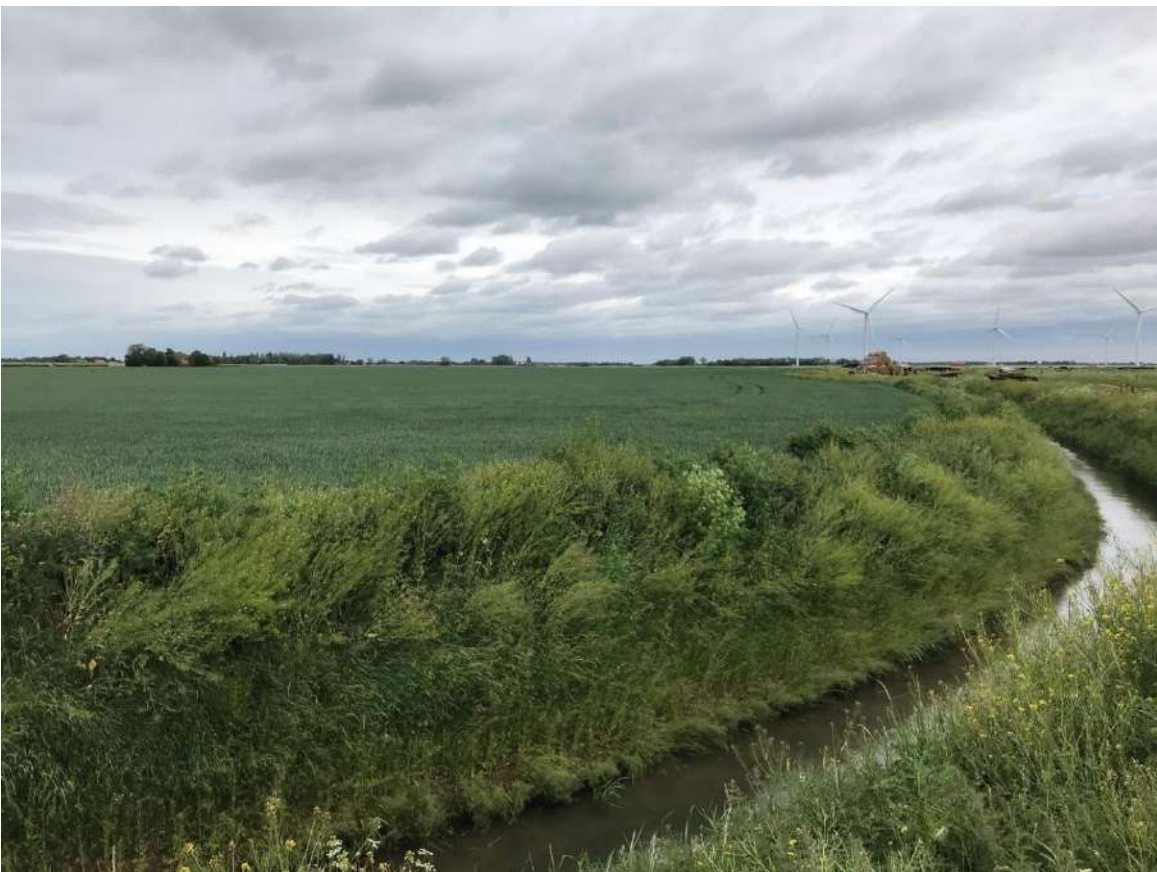
***Photograph 11-44: The Cut (Site 17a) View Downstream***

11.18.2 The drain was quite large at approximately 4 m bankfull width. The banks were steep and high (approximately 2 m) and vegetated with grasses and herbs. There was some marginal reed growth, and other submerged macrophytes appeared to be growing on the channel bed. Turbidity was quite high indicating the presence of fine sediment. The bed was not visible so substrate could not be observed, although it is assumed that it would likely be silty due to the high turbidity, slow flow and general low gradient, low energy conditions. A small road bordered the drain on one side, with agricultural fields on the other.

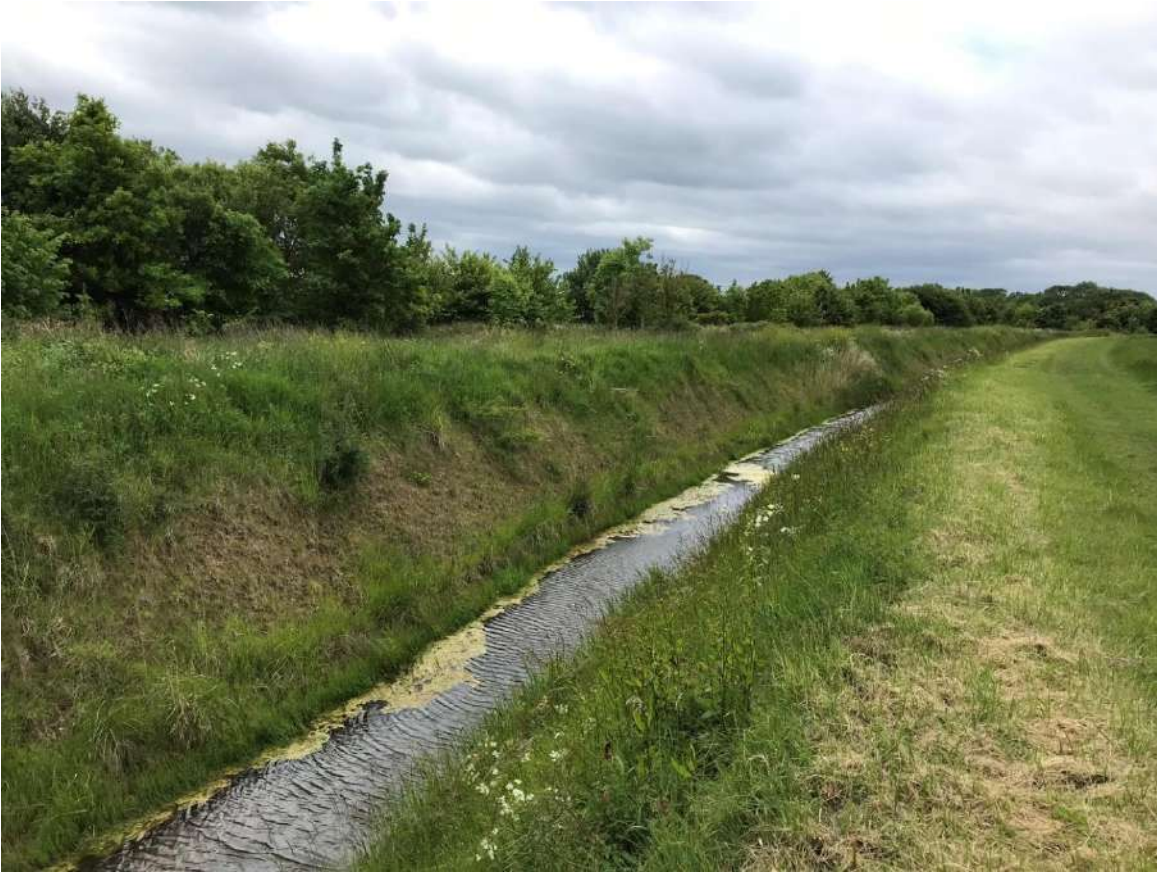
***Photograph 11-45: Two Mile Drain (Site 18) View Upstream***

11.19.2 Two Mile Drain comprised a linear channel set within flat agricultural land. It was connected to the same network of drainage channels as The Cut Drain. It had steep high banks of approximately 2-3 m. Algae was present in the channel indicating the input of nutrients. There was some marginal growth of grasses and other submerged broadleaved macrophytes were present on the bed. The bed appeared to be silty and sandy.

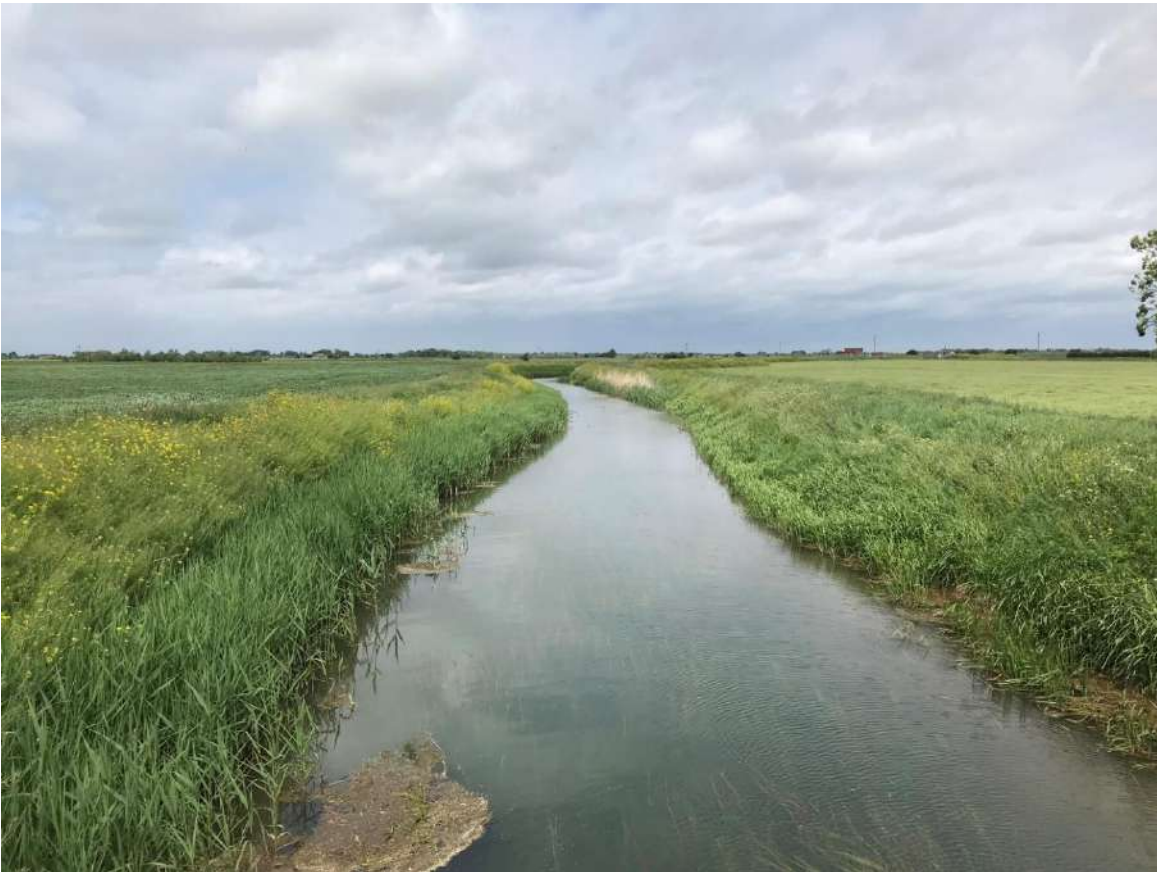
***Photograph 11-50: Great Eau (Site 22b) View Downstream***

11.21.2 The Great Eau comprised a channel of approximately 6-8 m bankfull width, with banks of approximately 2 m height. The bed was silty and sandy, and heavily vegetated with submerged linear leaved macrophytes. Flow was smooth and the water very clear. Channel margin vegetation consisted of reeds, while the banks were vegetated with grasses and herbs. Some reed growth was also observed on the channel bed. Surrounding land use was flat agricultural fields.

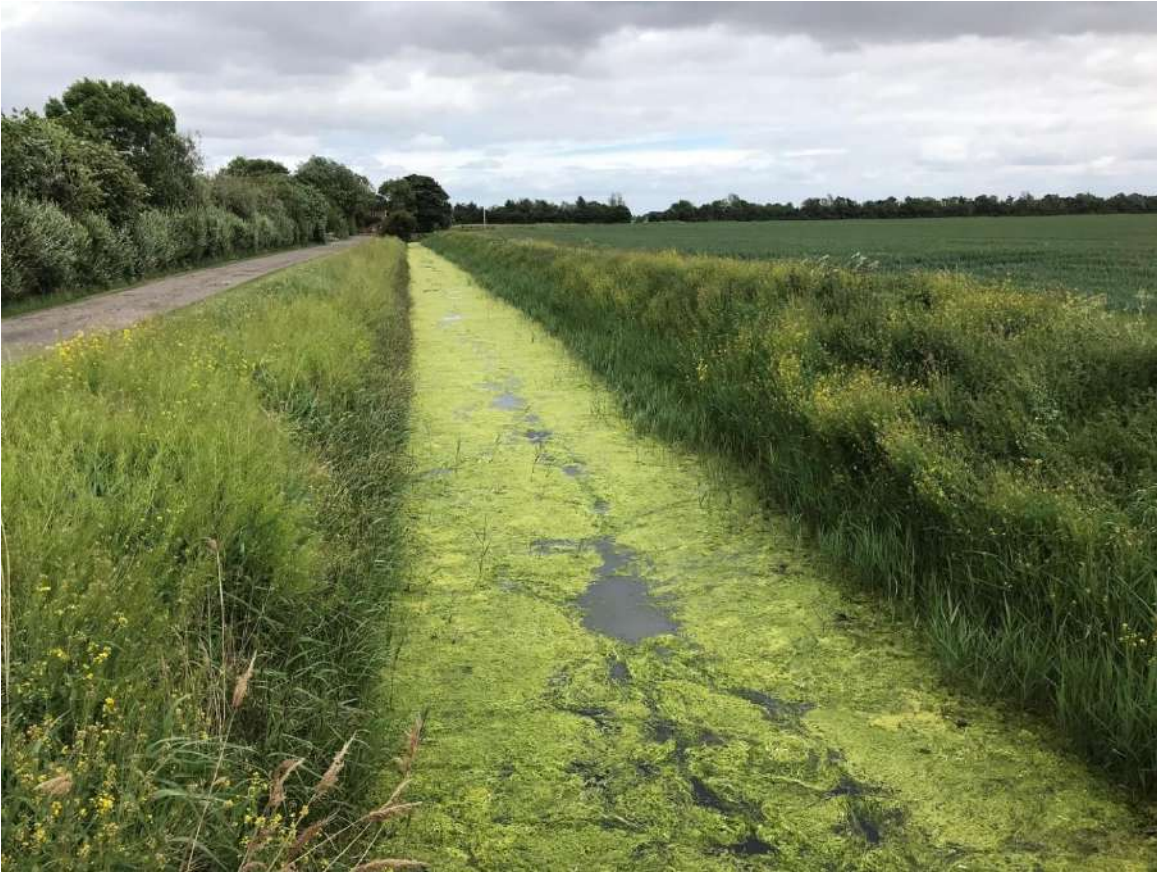
***Photograph 11-51: The Cut (Site 23b) View Downstream***

11.22.2 The Cut has been significantly modified, with a straightened and over deep channel devoid of morphological features as a result. The over deep channel was disconnected from the surrounding land, with steep, high banks of approximately 2 m height. There was no perceptible flow and the water was turbid, so it is likely that substrate was predominantly formed of silt. Water quality is likely to be an issue on the watercourse with very high algal growth which almost covered the entirety of the waters surface. Bank vegetation comprised taller grasses, while riparian vegetation was primarily agricultural farmland. A farm road was located on the left bank.
